# Newsletter of **Environmental, Disaster, and Crises Management Strategies**

Issue No. 32 | July 2026

## **The 24 June 2026 Venezuela Earthquakes**

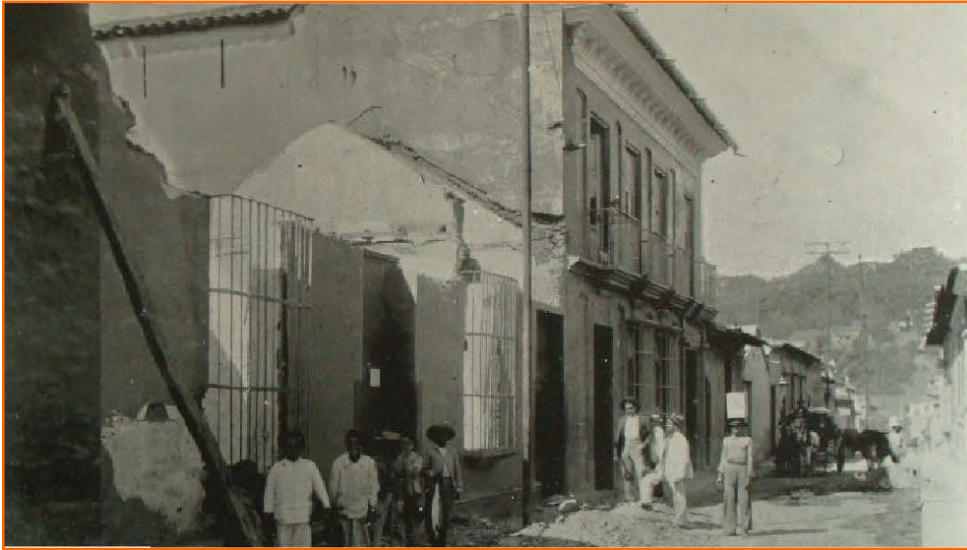
House that formerly housed the Protestant church, Caracas.

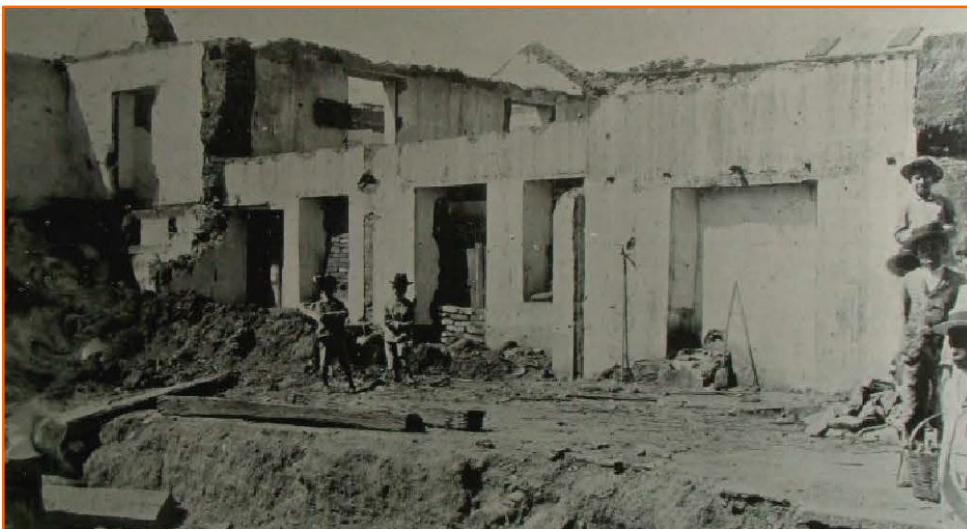
Partially collapsed house at the corner of Los Traposos, toward the southwest of Caracas.

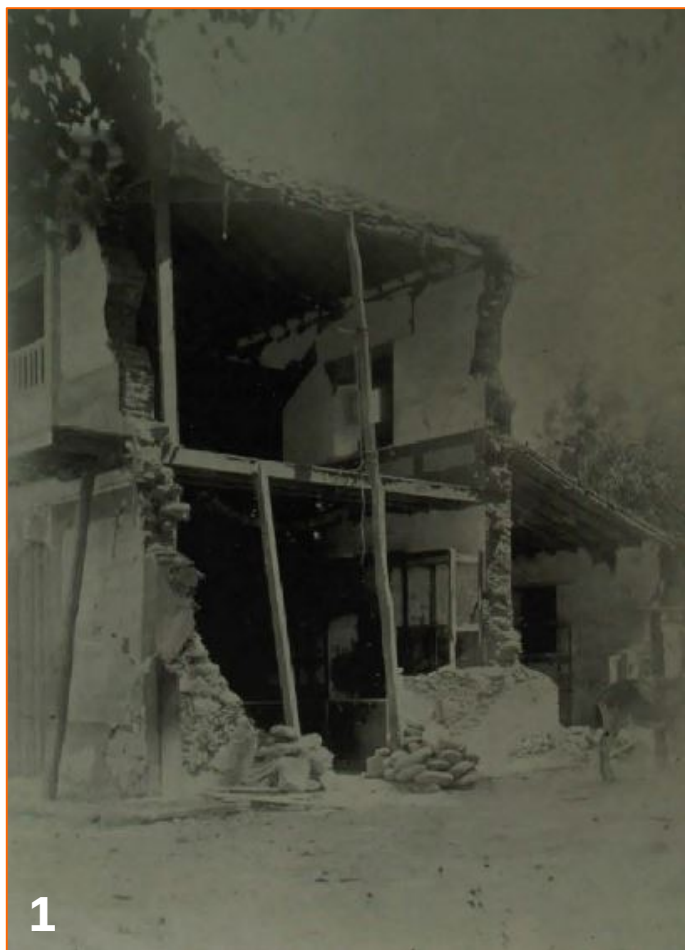
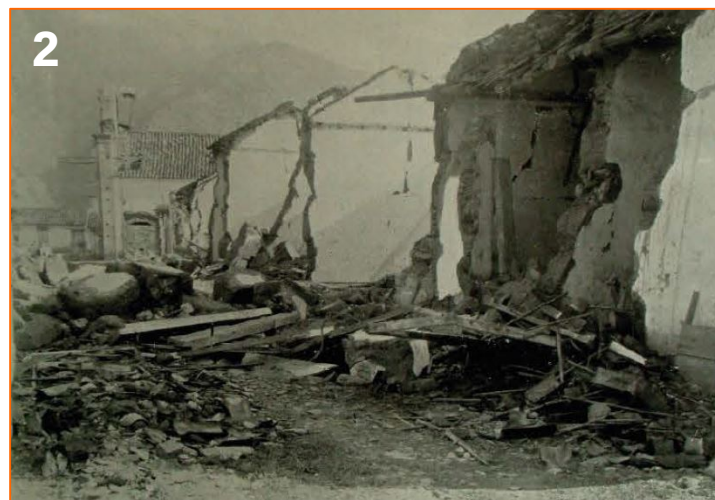
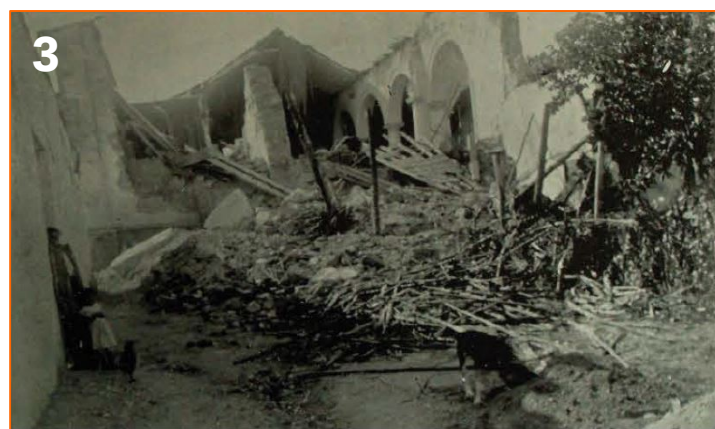
**1.** Casa La Ceiba, belonging to the Morales Brothers, Macuto.

**2.** Jiménez Street, Guarenas. **3.** Main Church, Guatire. Available online at:

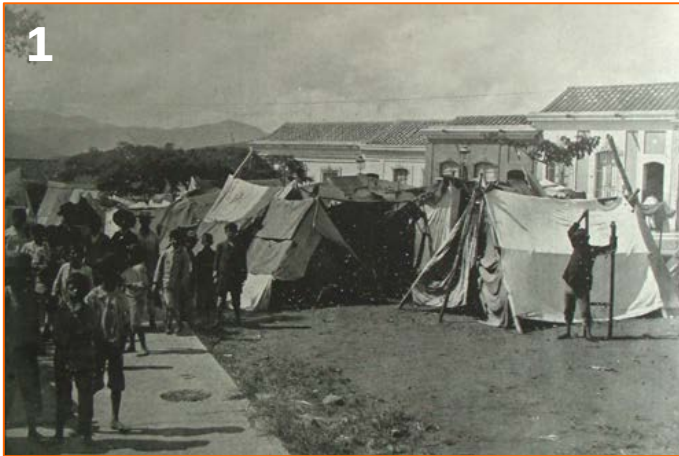
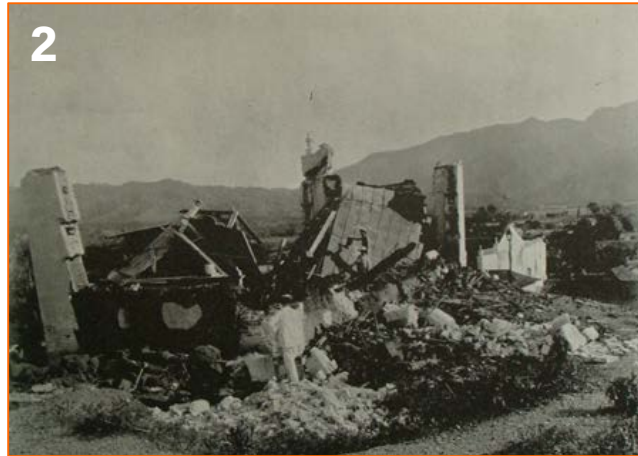
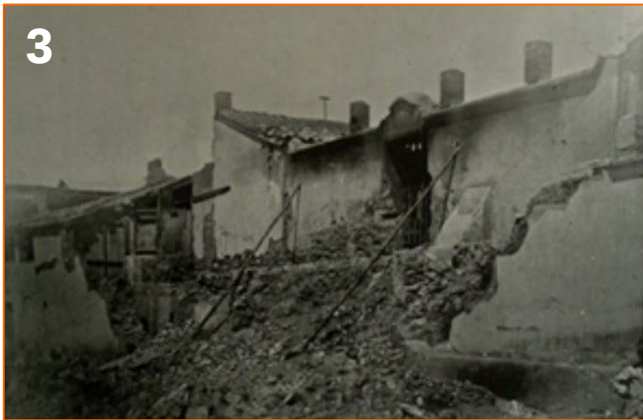
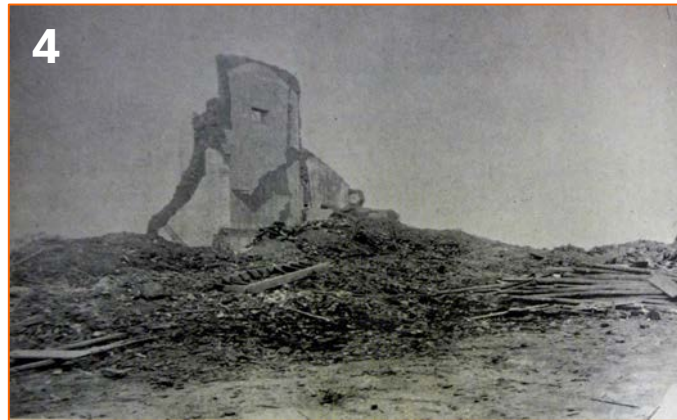
- (1) 1900 earthquake.  
Camp in La Pastora.  
(2) Guatire.  
Ruins of the El Calvario  
Chapel and the entrance  
façade of the Parish Church.  
(3) Effects of the 1900  
earthquake on a house in  
Caracas.  
(4) Maiquetía.  
Ruins of the Parish Church  
after the earthquake.

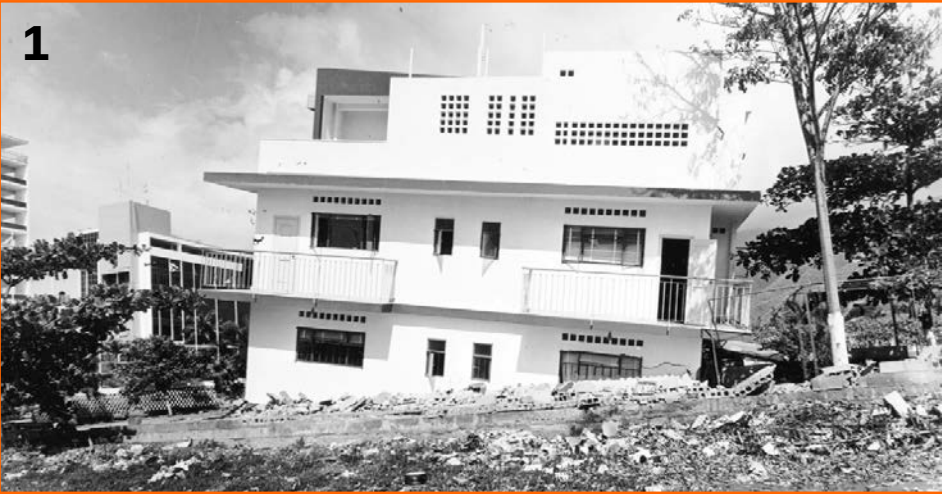
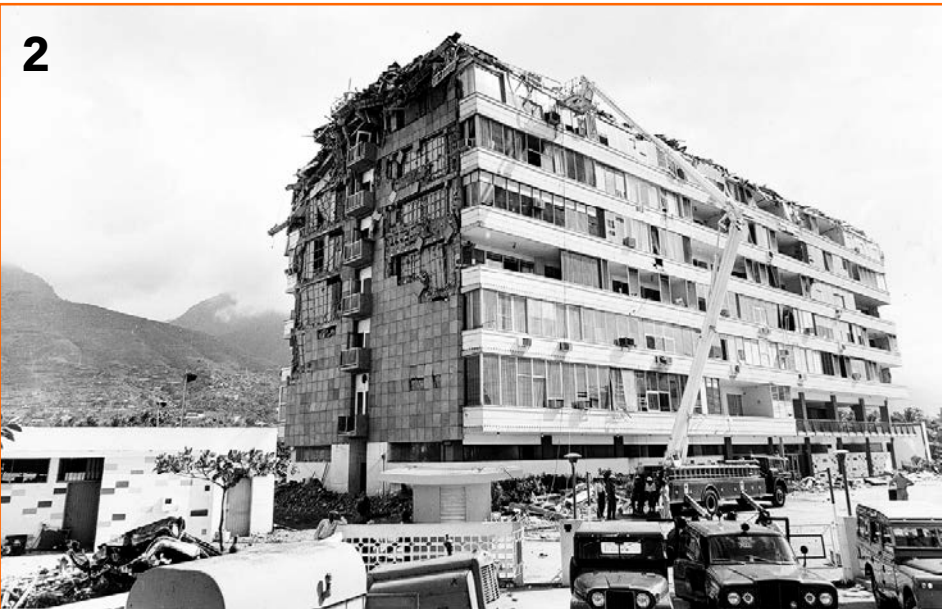
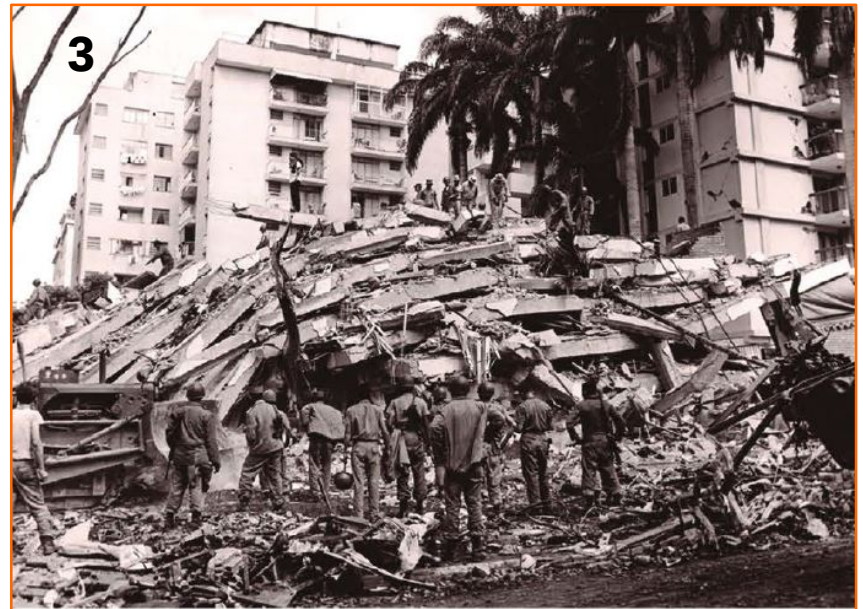
1. House affected by liquefaction. Caraballeda, Central Coastal Region.

2. The Charaima Mansion, Caraballeda, 1967. The structure was originally designed for six floors. However, four additional floors were later added, which collapsed from the earthquake.

3. Rubble of the Mijagual Building. Source: Earthquake Investigation Commission (1967).

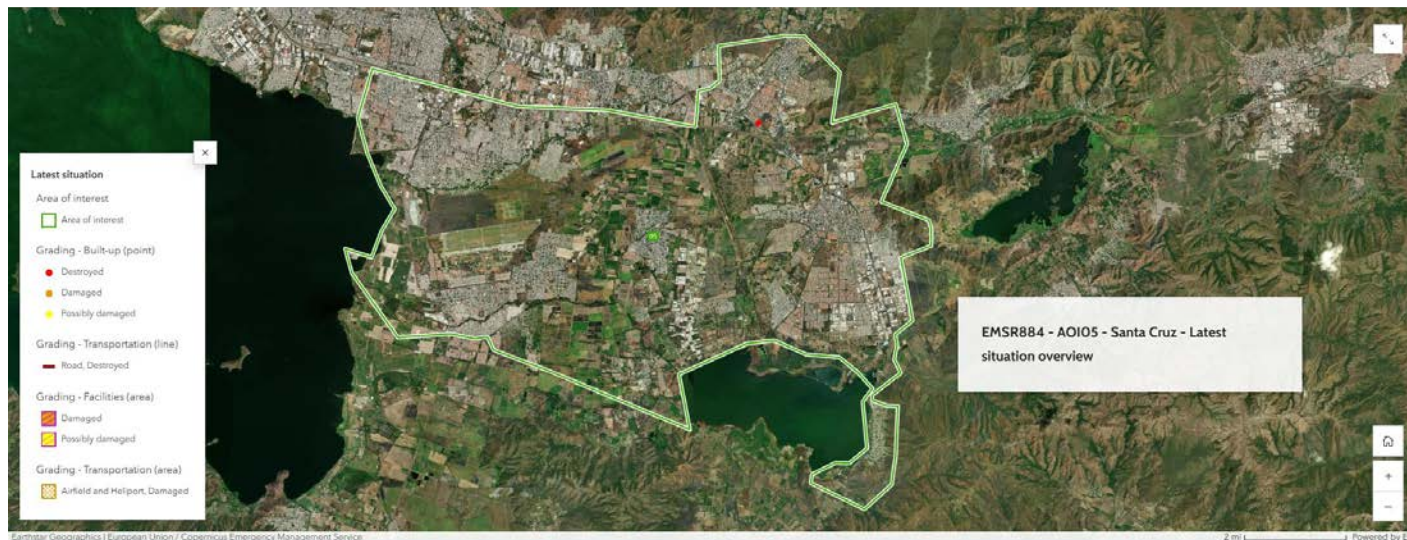
According to the emergency mapping produced by the Copernicus Emergency Management Service (CEMS), Caracas and Santa Cruz were the least affected areas, with the lowest numbers of affected and collapsed buildings.  
(up) Caracas.  
(down) Santa Cruz.

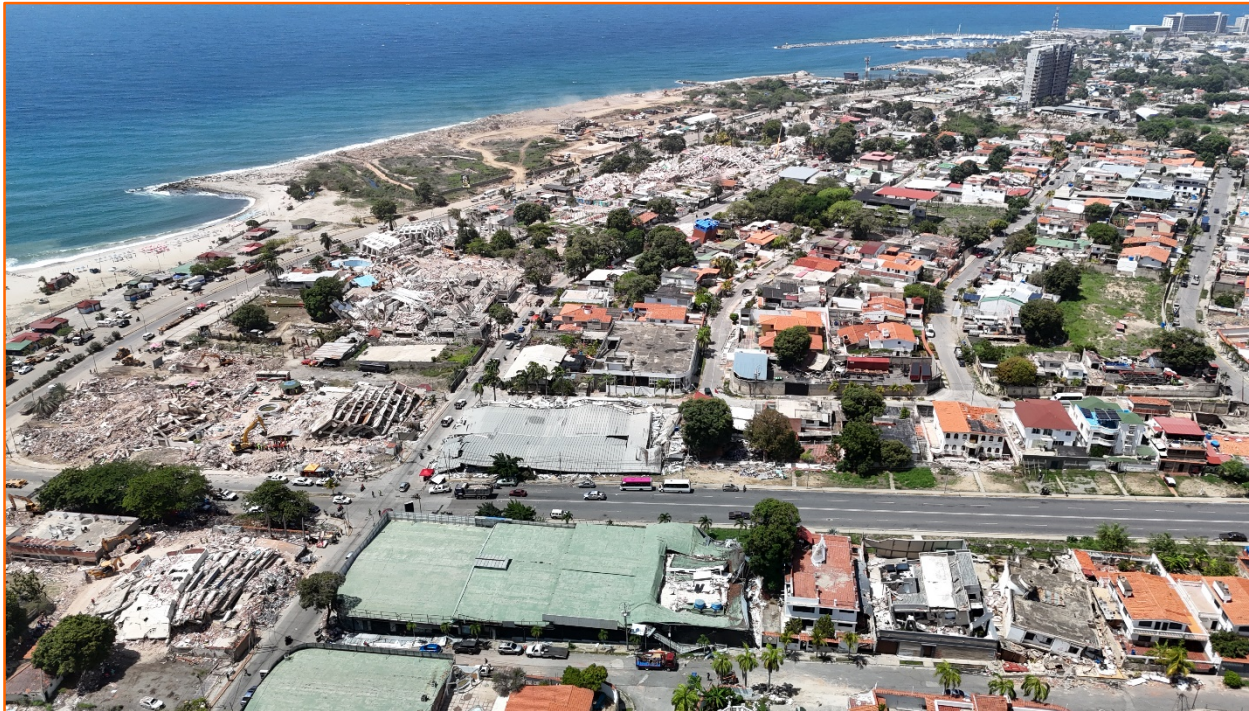
The heavily affected narrow coastal zone of Caraballeda with extended collapses of high-rise buildings in a small distance from the sea front.

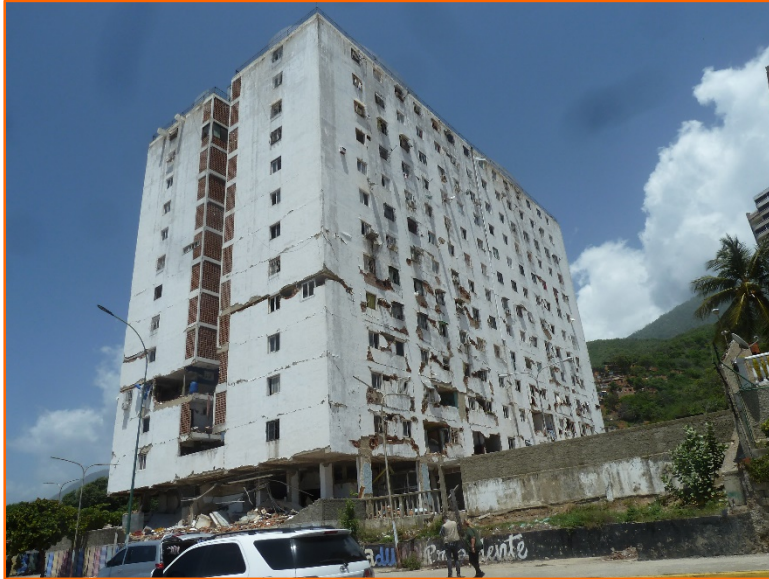
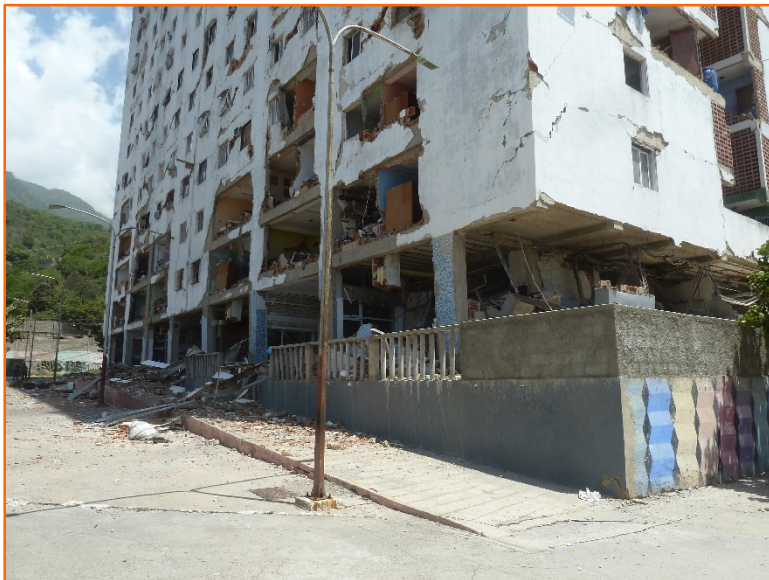
Representative case of a multi-storey RC building in the coastal Caraballeda, north of Caracas, showing damage concentration in the lower storeys. While the upper storeys remained largely undamaged and almost intact, the lower levels exhibited extensive damage to the masonry infill panels, including separation from the RC frame and partial to complete collapse.

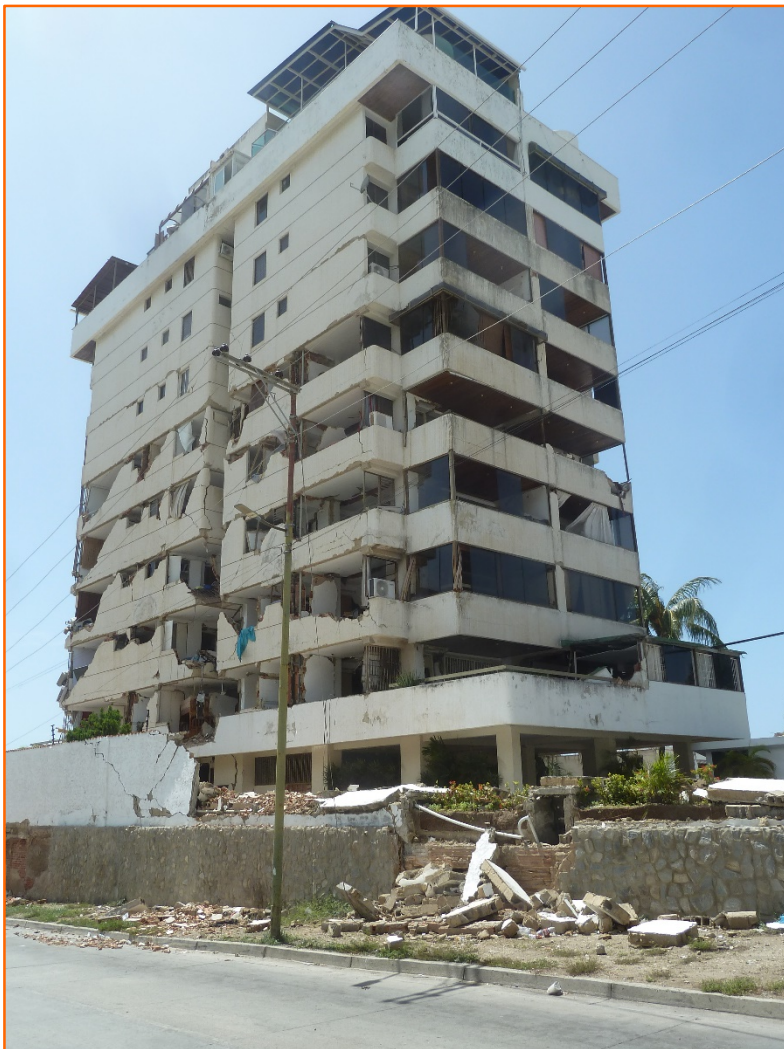
Typical cases of multi-storey RC buildings in the coastal Caraballeda, north of Caracas, showing damage concentration in the lower storeys. Photos by Lekkas and Carydis.

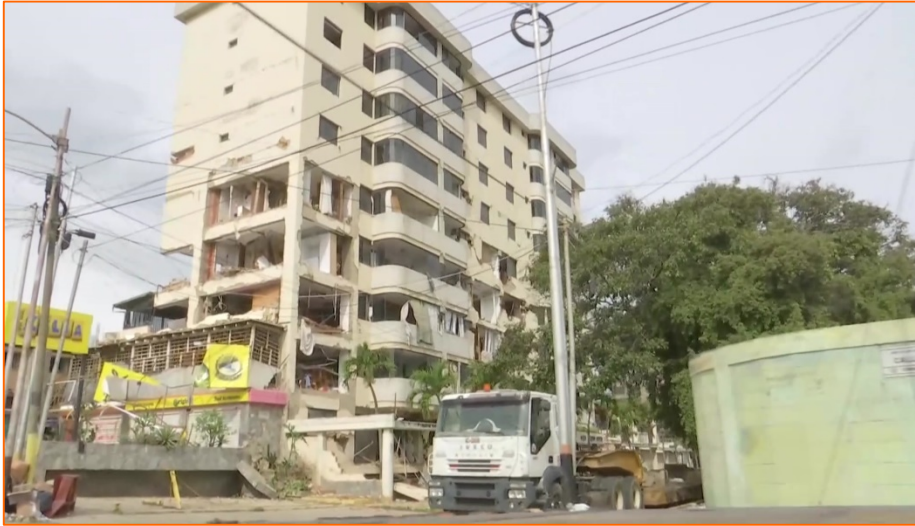
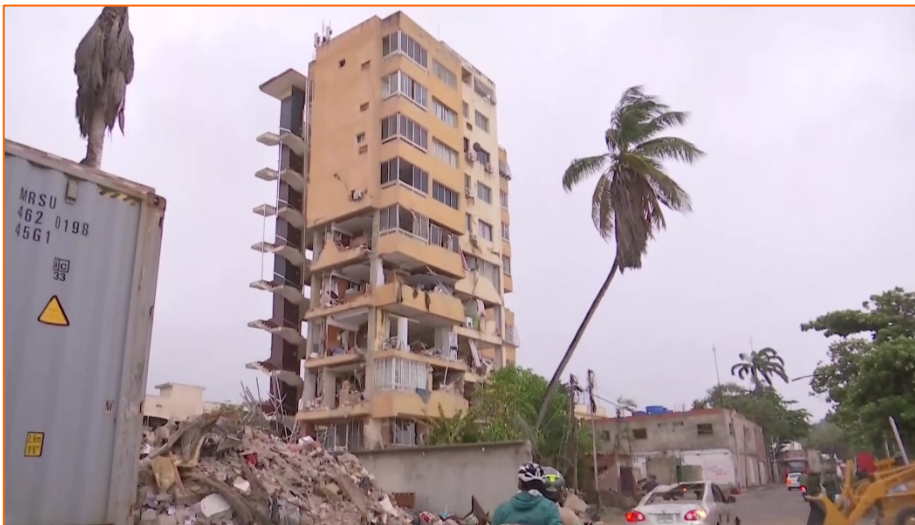
Representative case of multi-storey RC buildings in the coastal La Guaira state, showing damage concentration in the lower storeys.

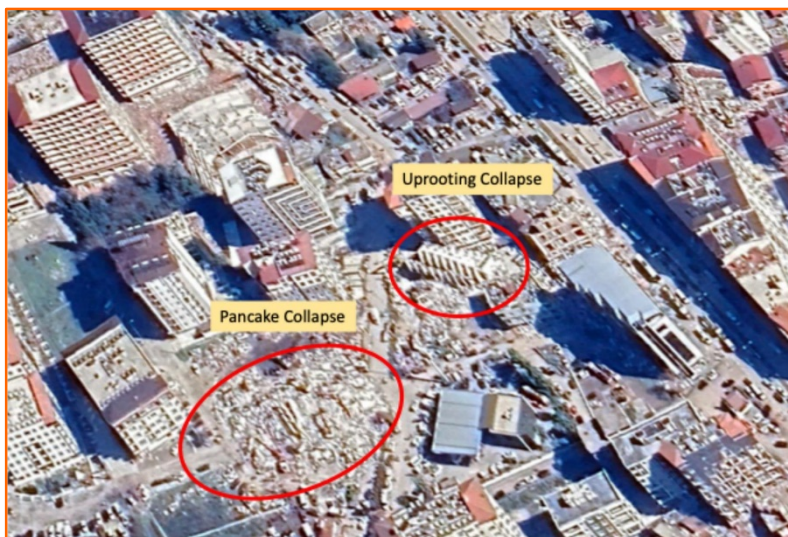
Comparison of uprooting collapse and typical pancake collapse observed in post-earthquake satellite images from Antakya City, which was affected by the early 2023 southeastern Turkey earthquakes.

In the pancake collapse, the structure is reduced to rubble, obscuring structural details, whereas in the uprooting collapse, the floors and contours of the load bearing RC frame remain clearly visible.

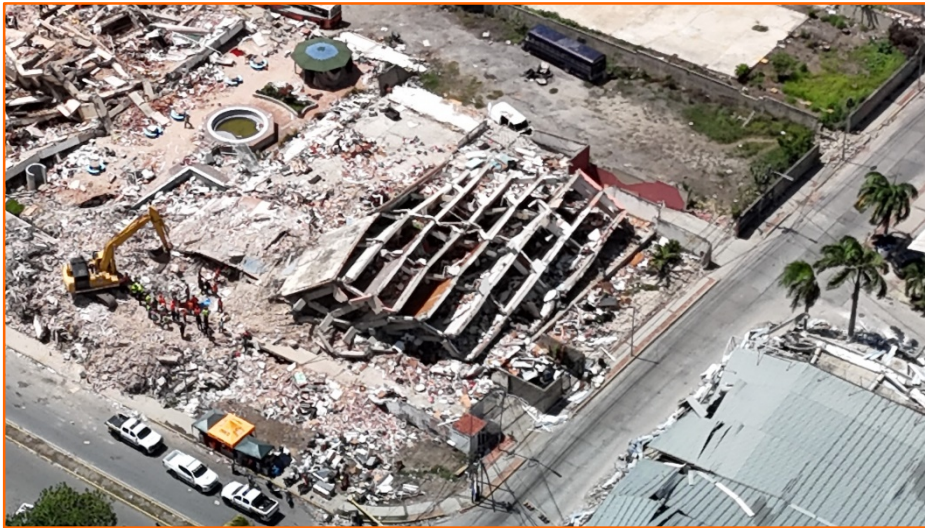
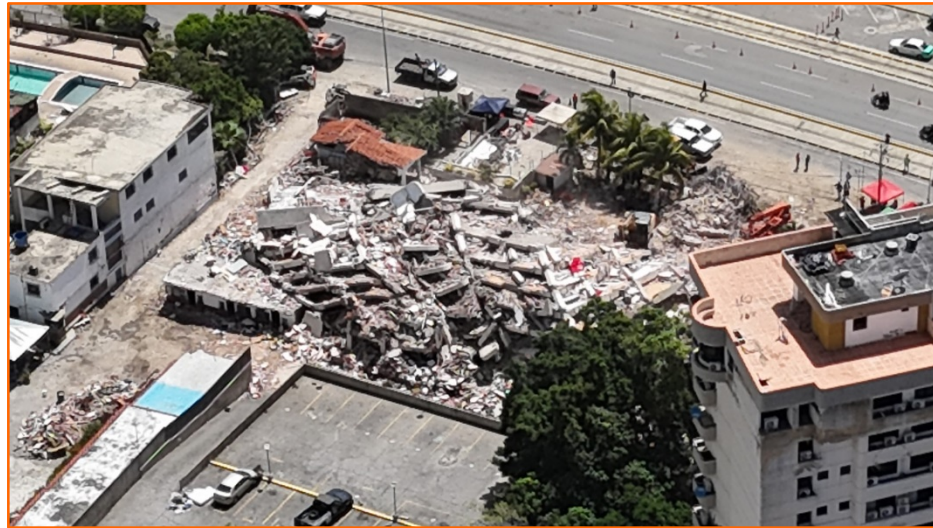
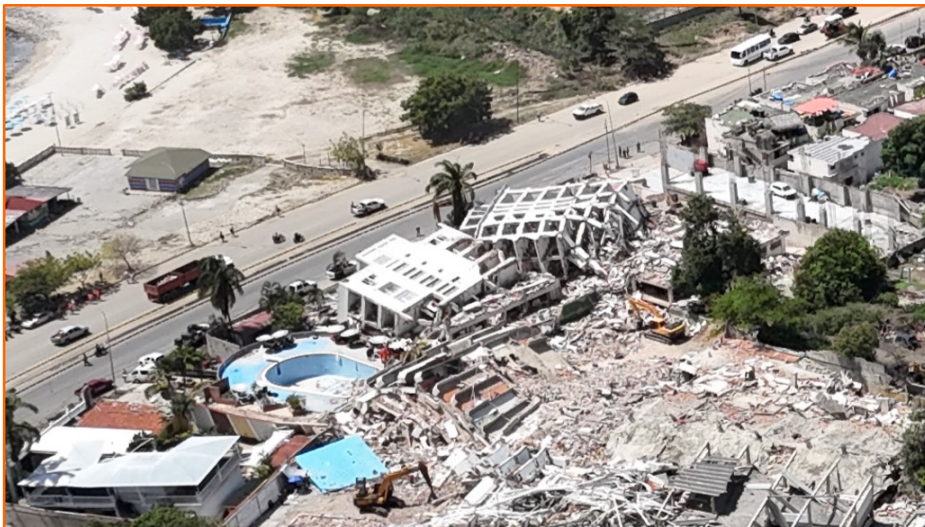
Representative view of buildings exhibiting uprooting collapse in the coastal area of Caraballeda

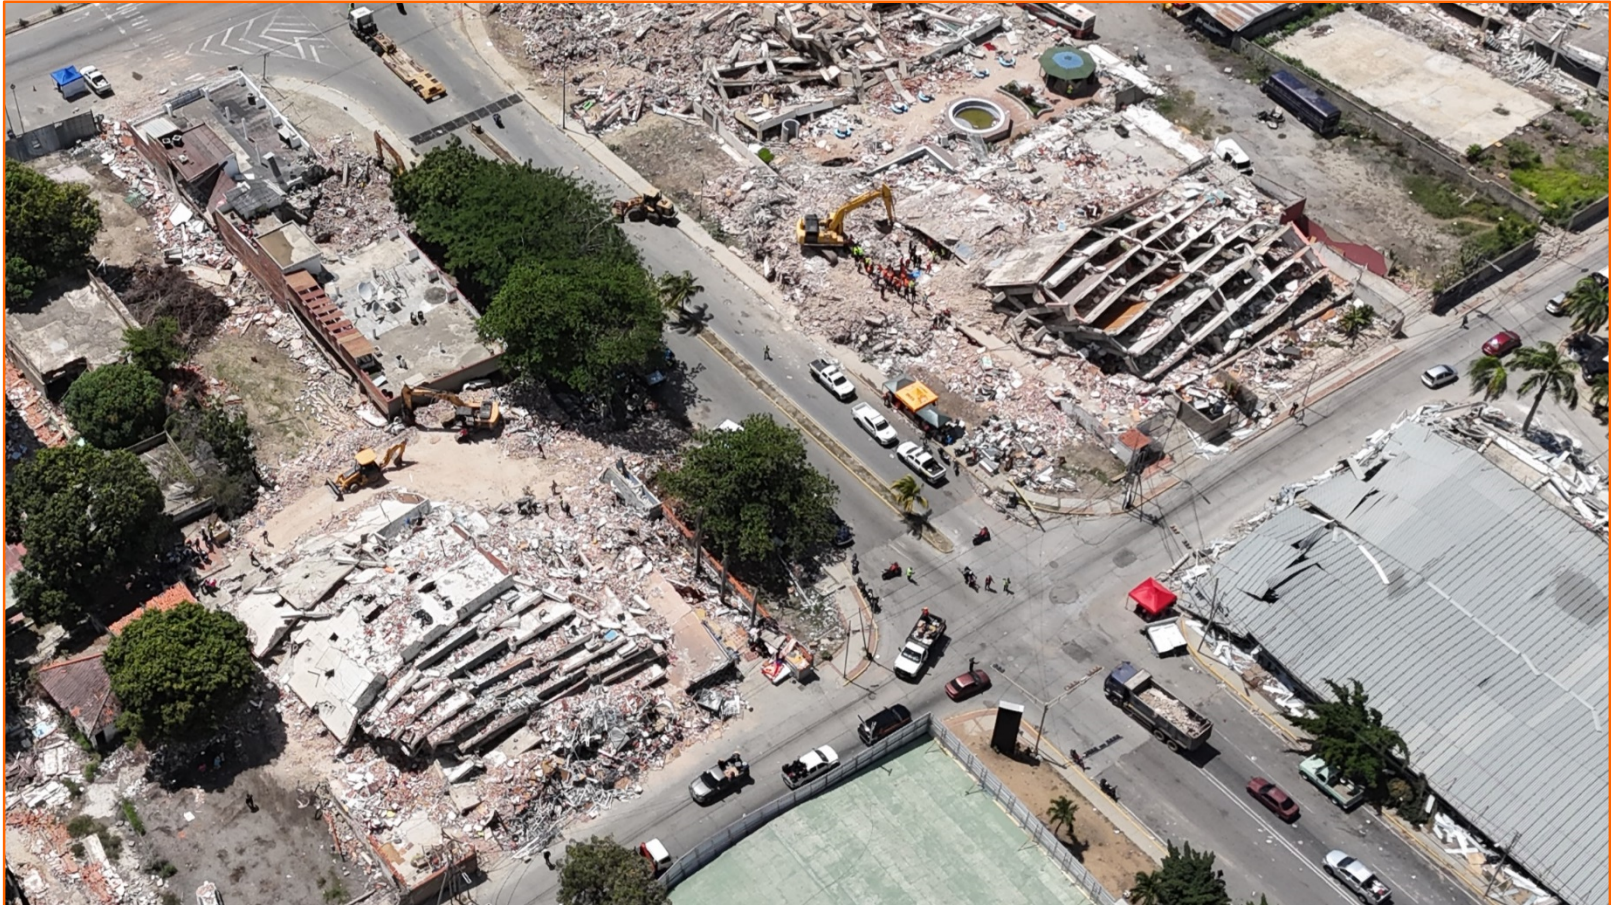
Pancake and uprooting collapse mechanisms are shown on the left and right sides of the image, respectively. The pancake collapse obscures the structural configuration of the building, whereas the uprooting collapse may leave the structural members exposed and clearly identifiable. Photos by Lekkas and Carydis in Caraballeda area.

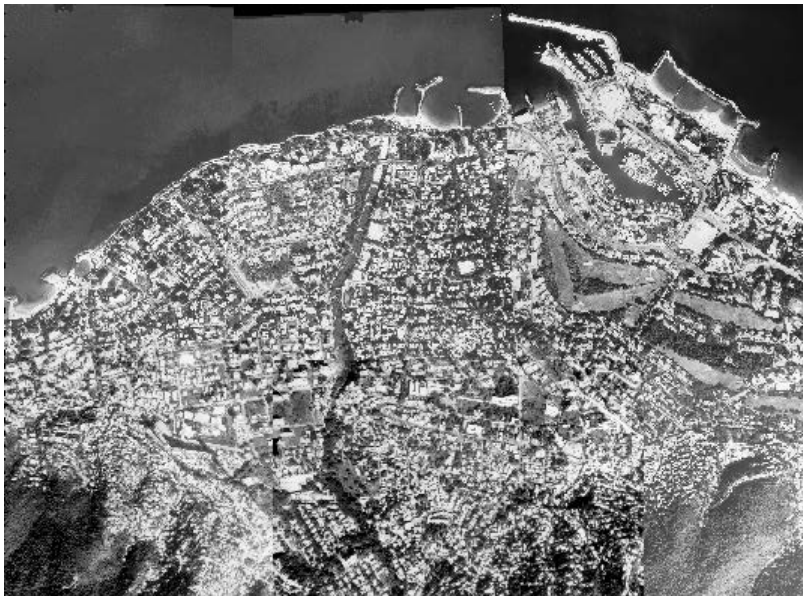
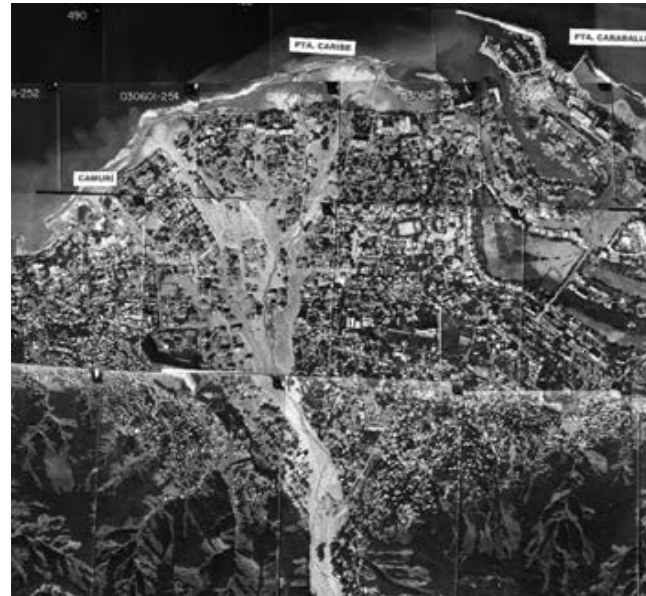
▼ Aerial photos of the alluvial fan of San Julian River taken in 1998 (left) and a few days after the December 1999 disaster (right).

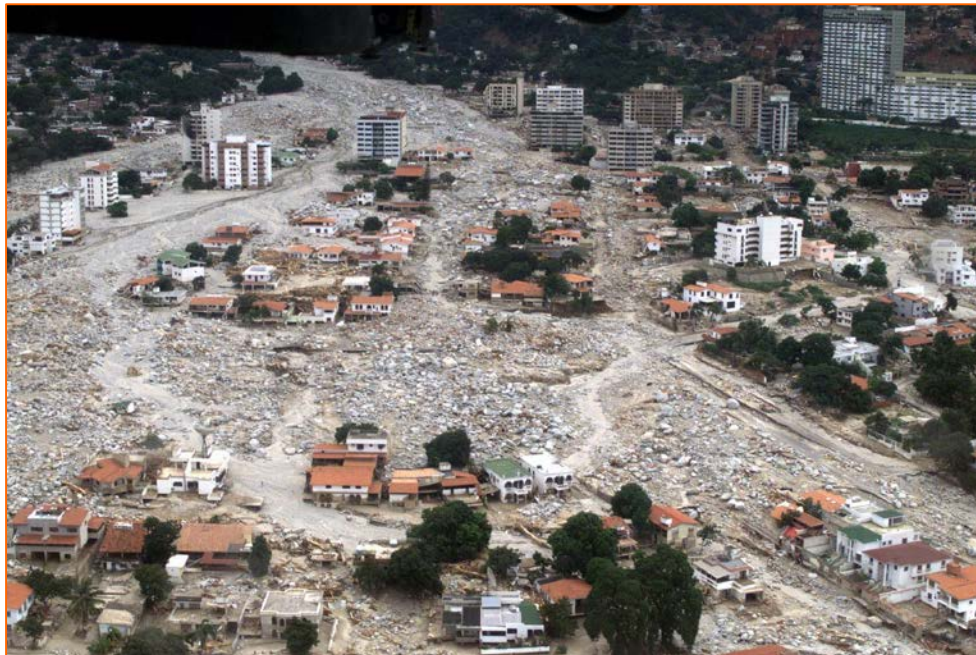
Aerial view of debris-flow deposition resulting in extensive destruction on the Caraballeda fan. The debris volume reached 1.8 million m<sup>3</sup> and the thickness up to 6 meters (after Wieczorek et al., 2001).

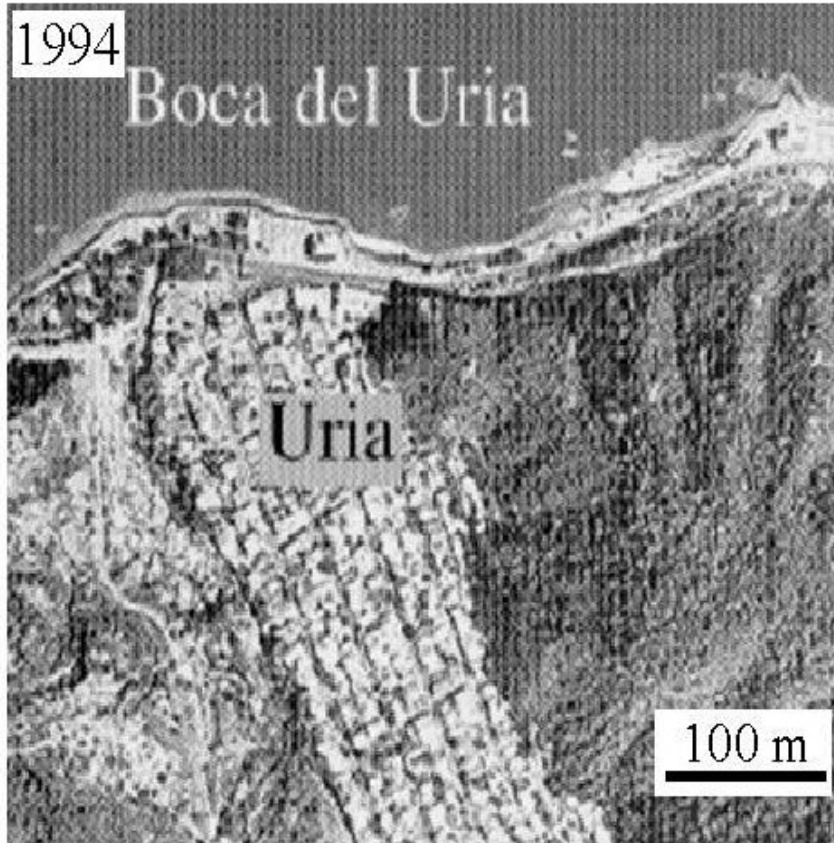
Aerial photographs taken in 1994 and after the December 1999 event illustrating the destruction of the Carmen de Uria community and shoreline progradation (after Larsen et al., 2001).

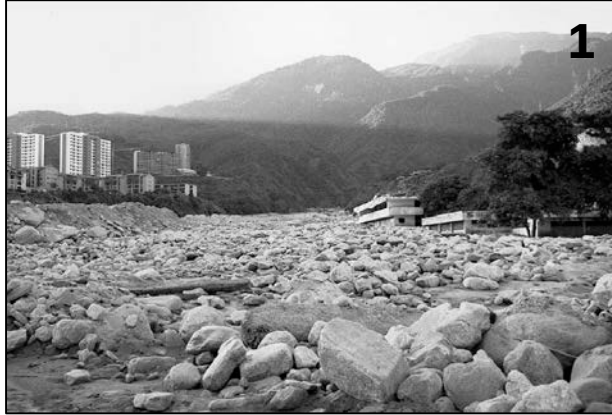
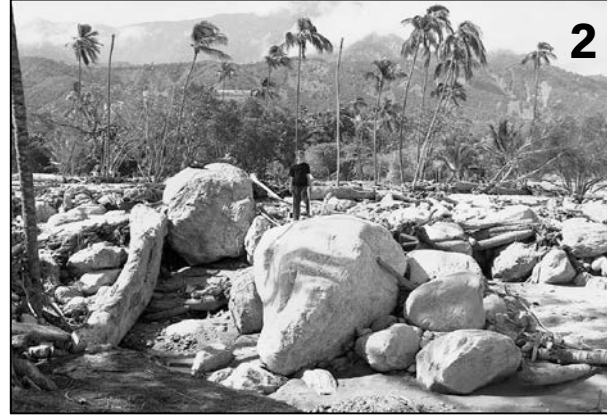
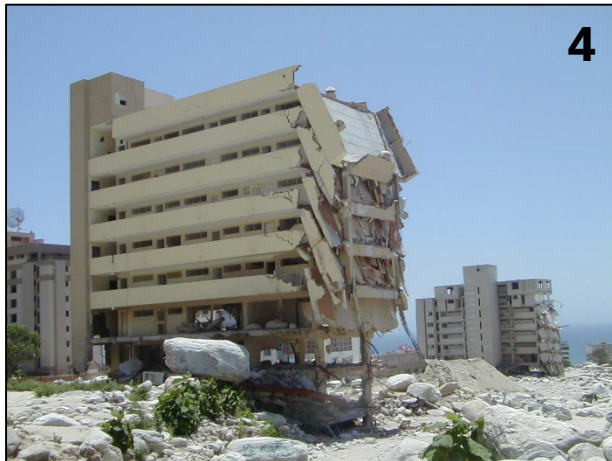
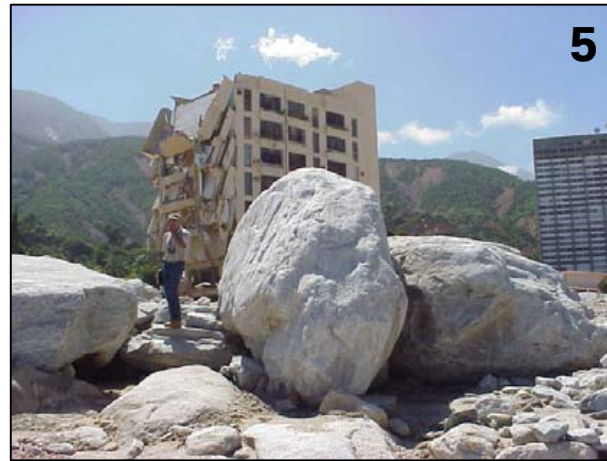
Impact of the boulder-rich debris generated by the December 1999 debris flows on several coastal areas of northern Venezuela and on RC buildings constructed on the alluvial fans of the region.

Large residential areas were swept away by the debris flows and associated floods. Small buildings were buried beneath the deposits, whereas high-rise RC buildings partially or completely collapsed due to impacts from large boulders.

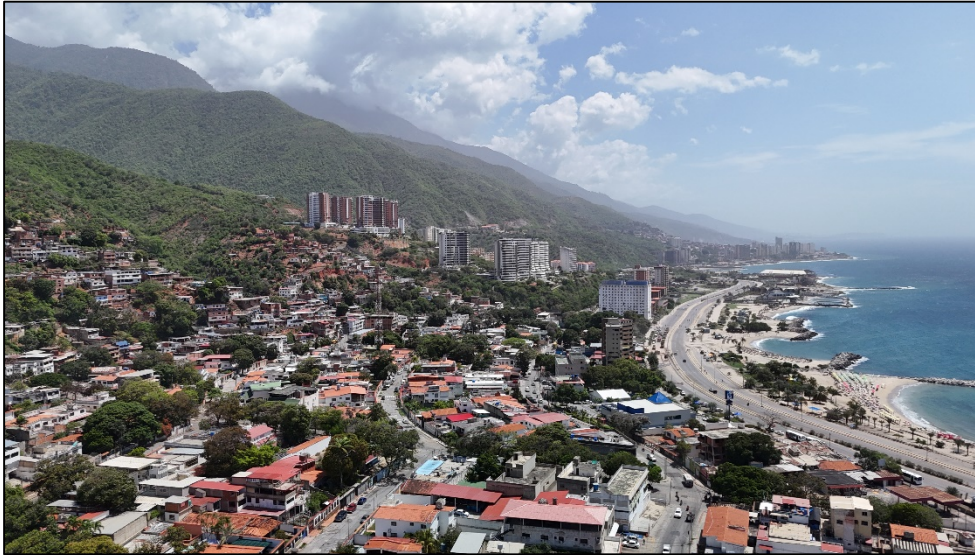
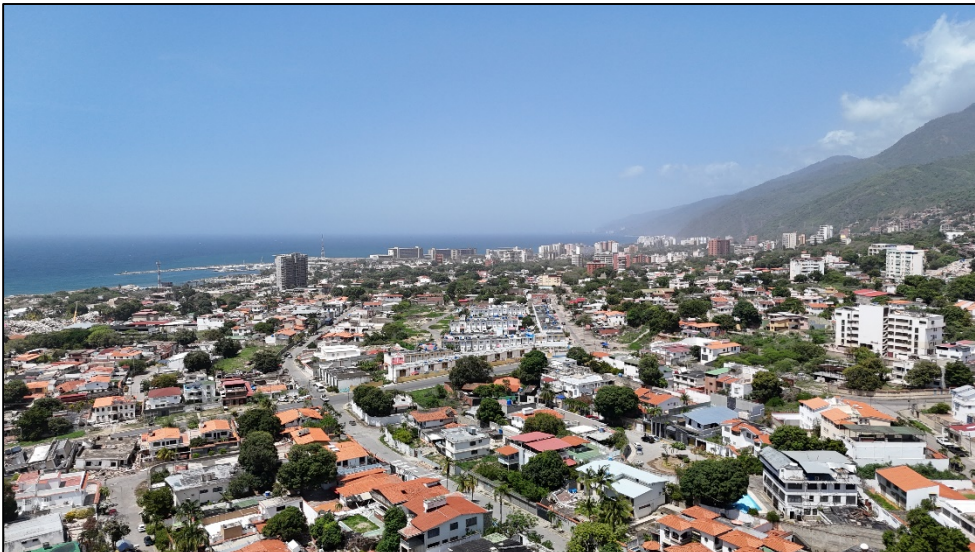
(up) View from Caraballeda area towards W.

(down) View from Caraballeda area towards E.

In both views, the transition from the alluvial fans towards the coastal zone occurs through steep, high-relief slopes that represent prominent geomorphological discontinuities and exhibit increased susceptibility to slope instability phenomena, including rockfalls and soil slides.

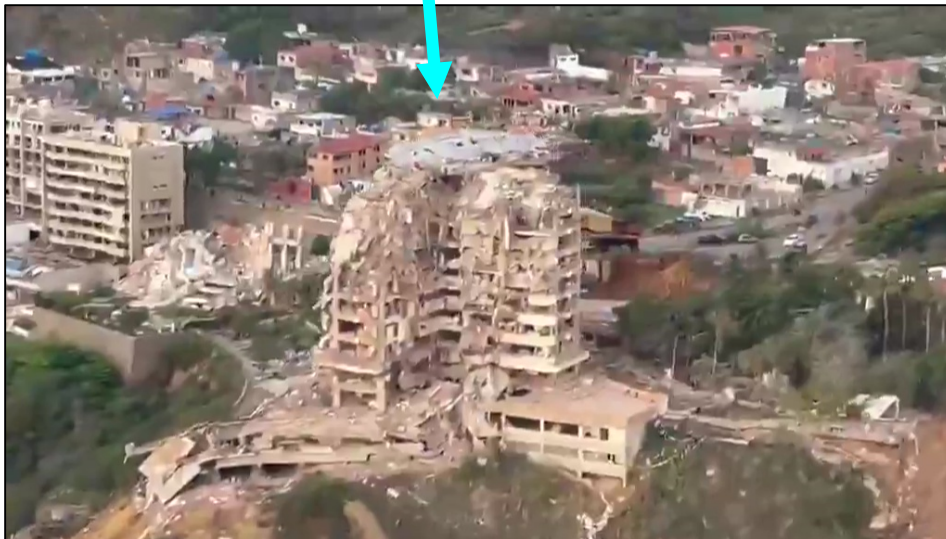
Abrupt topographic changes and morphological discontinuities may induce local amplification of seismic ground motions due to topographic effects. Furthermore, the reduction in slope stability during strong seismic loading increases the likelihood of earthquake-induced landslides.

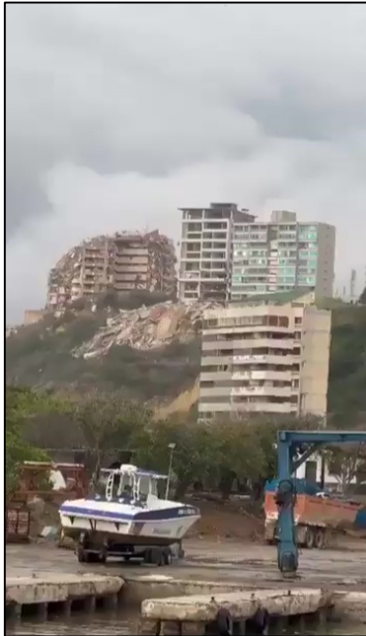
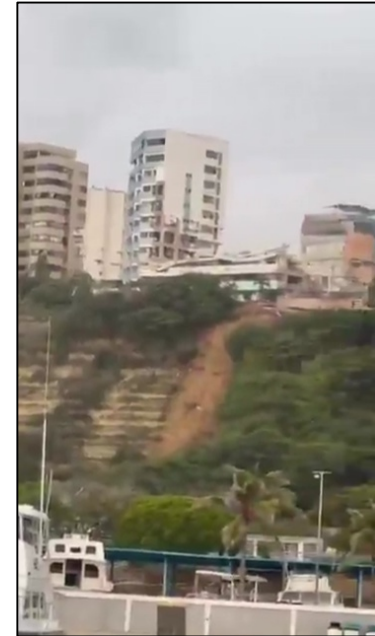
Representative views of the post-earthquake situation close to the crest of steep slopes in La Guaira sector located in the coastal zone of the Northern Venezuela. Several recently constructed buildings were heavily damaged and suffered partial or total collapse with building debris fallen on the slope surfaces.

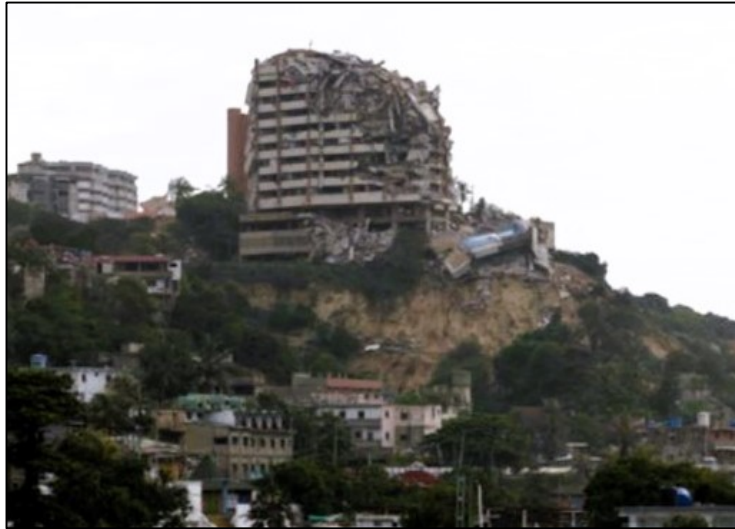
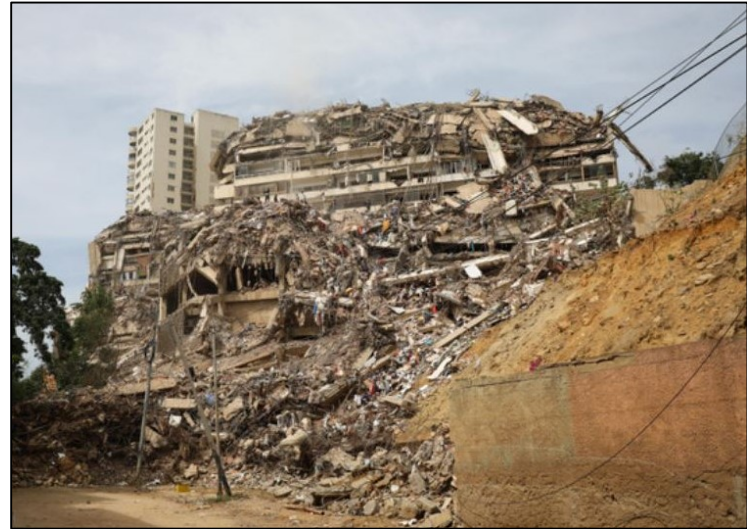
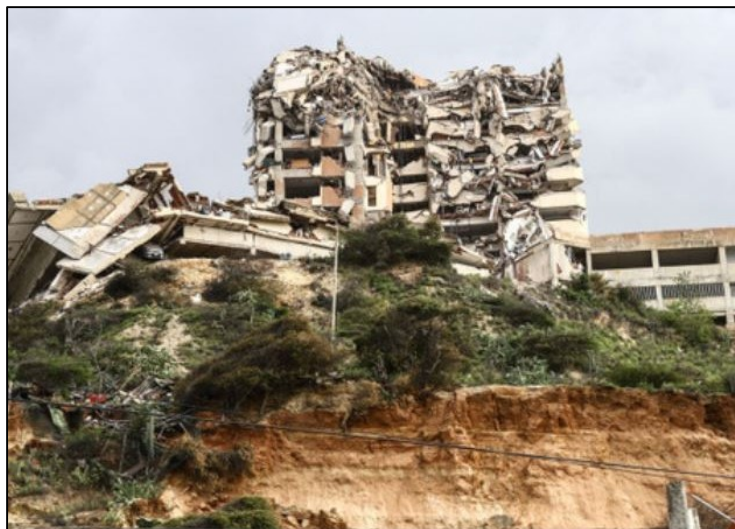
Typical example of a partially collapsed building located near the crest of the steep slopes in La Guaira State. The transition zone between the alluvial fans and the flat coastal plain amplified seismic ground motion, leading to increased ground-shaking intensity and, consequently, more severe structural damage.

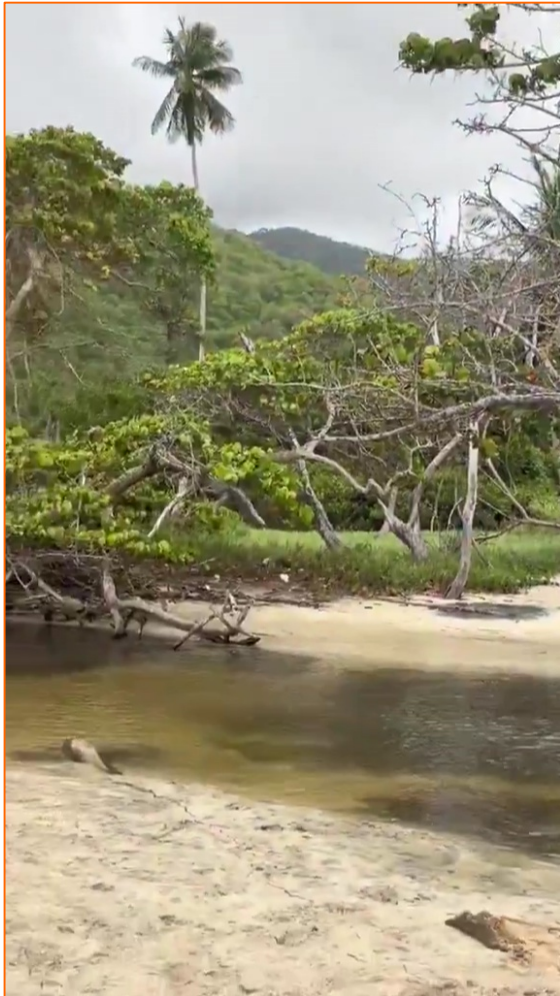
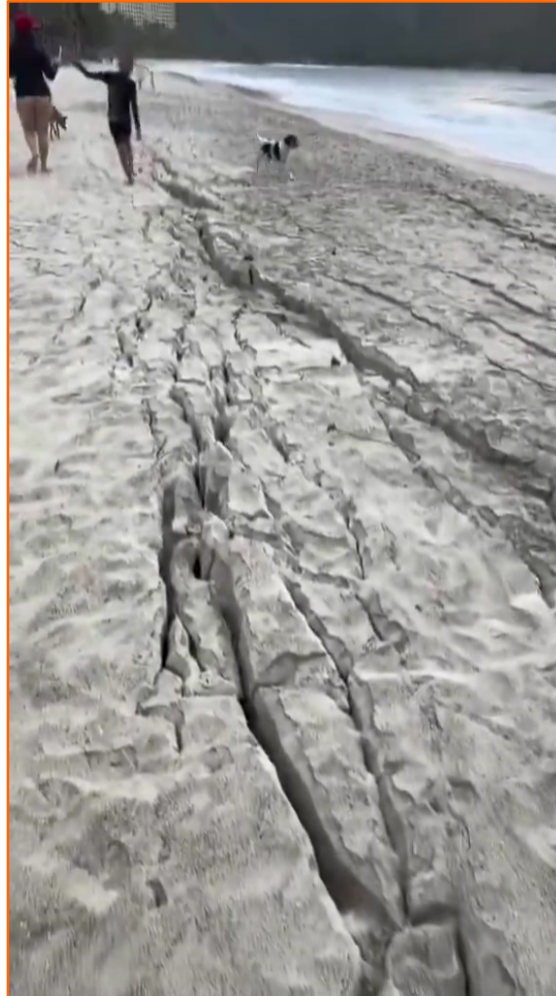
Liquefaction phenomena observed at **Bahía de Cata** Beach, Cata Bay, Aragua State, northern Venezuela, included the ejection and surface flow of liquefied soil material, as well as the development of ground cracks associated with earthquake-induced lateral spreading toward the shoreline. The extrusion and flow of liquefied material were also observed on the seabed, indicating the occurrence of submarine liquefaction-related ground deformation.

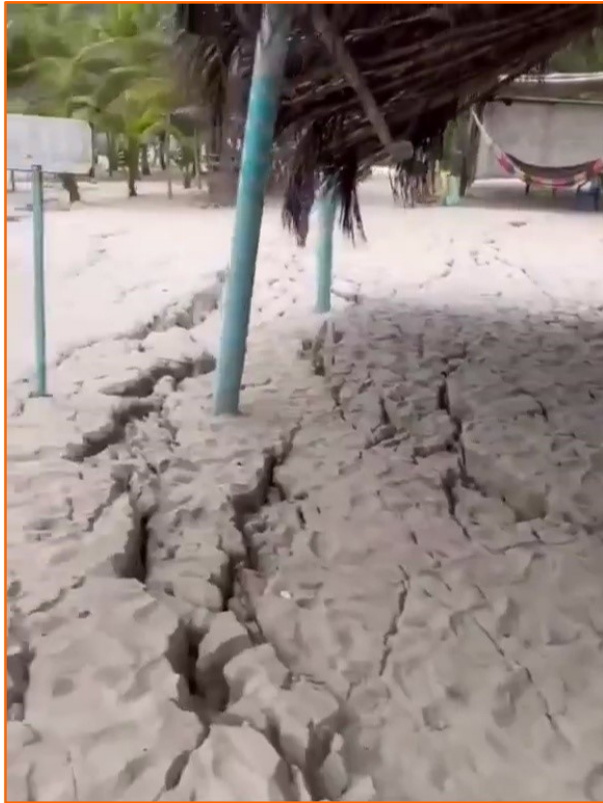
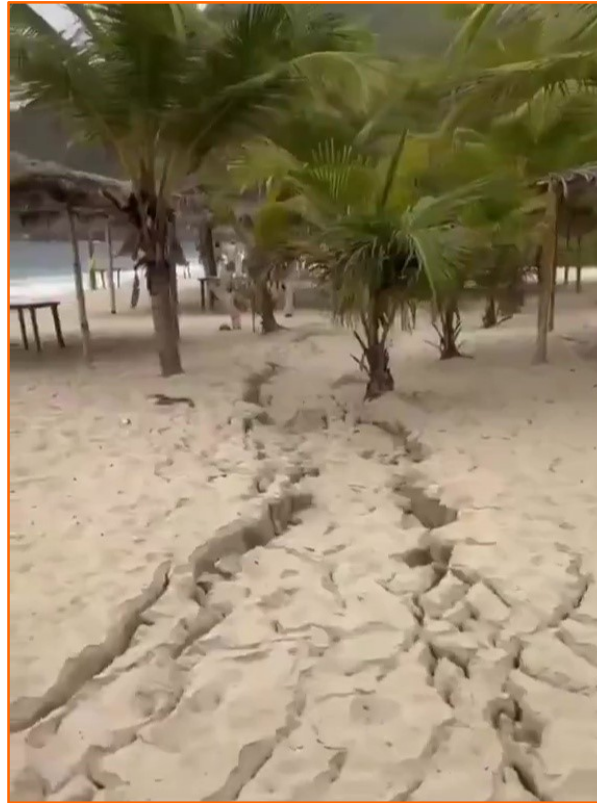
The ground cracks due to lateral spreading observed in **Bahía de Cata** Beach, Cata Bay, Aragua State, northern Venezuela also affected touristic facilities constructed in the sandy beach.
