# Newsletter of **Environmental, Disaster, and Crises Management Strategies**

Issue No. 32 | July 2026

## **The 24 June 2026 Venezuela Earthquakes**

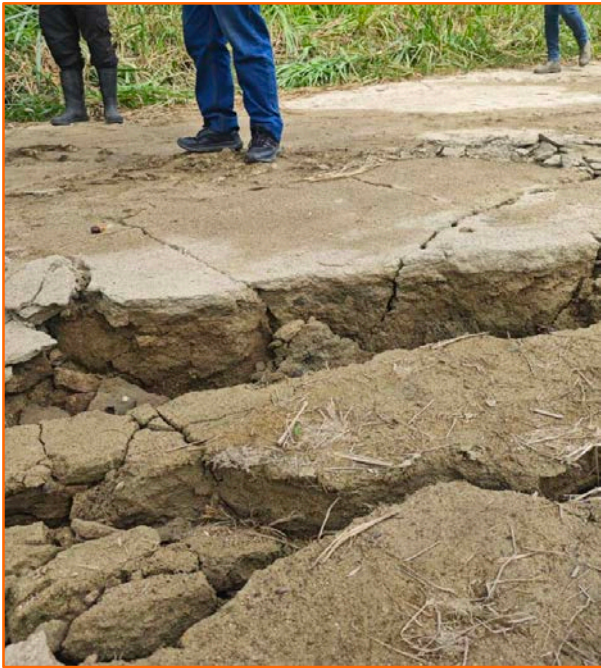
Liquefaction was also triggered in the municipality of **Veroes**, in the state of Yaracuy, The phenomena was similar to what was documented during the 1997 Cariaco earthquake. The 2026 phenomena included ground cracks and ejection of liquefied material to the surface, resulting in sand boils. The photographs were provided by the staff of the Ministry of Science and Technology of Venezuela and their related report, which is available online at: <https://mincyt.gob.ve/la-estabilidad-de-nuestros-suelos-y-el-reto-de-la-licuacion/>

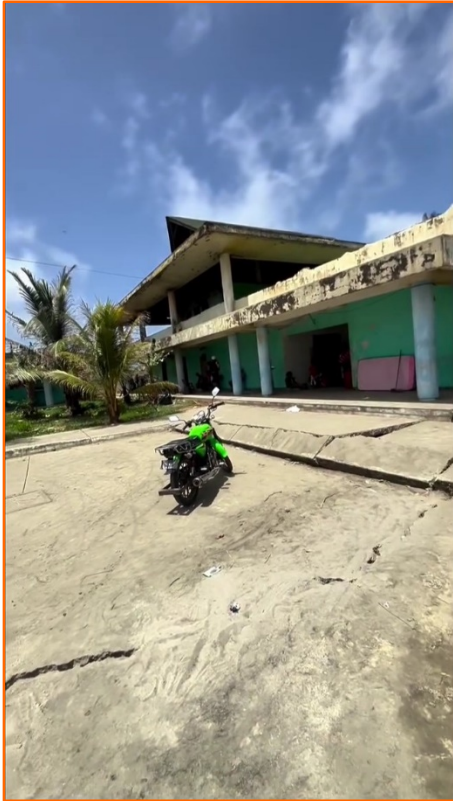
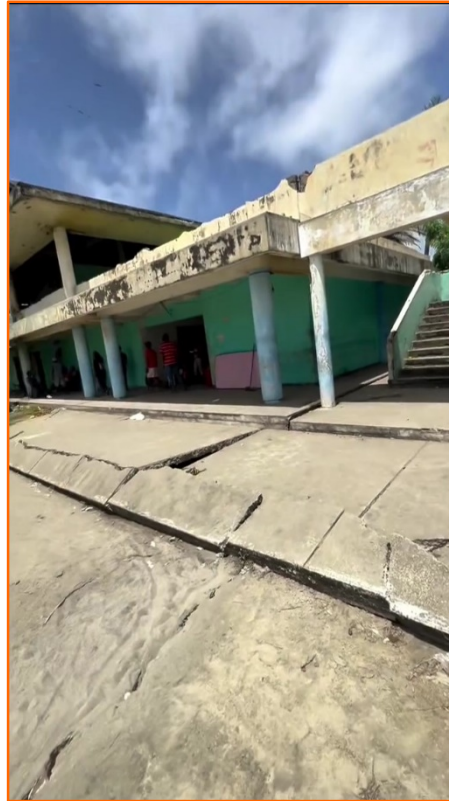
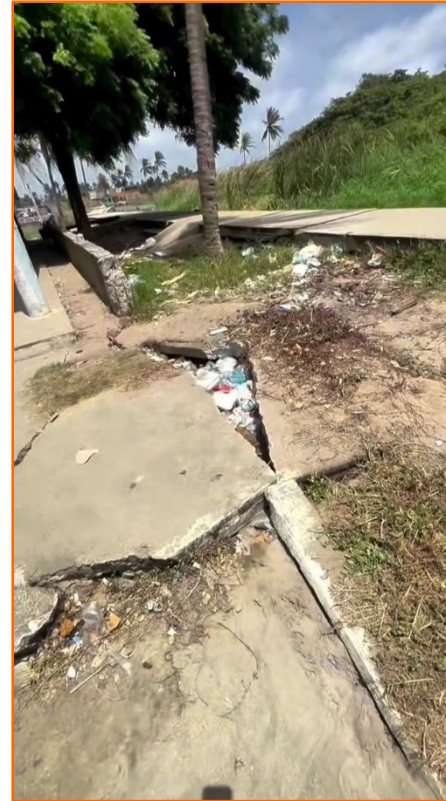
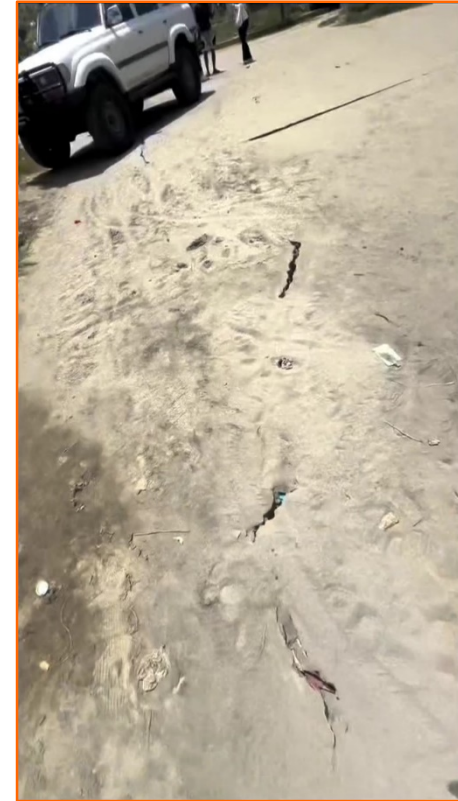
Following the 24 June 2026 earthquakes, several structures in the area **El Río en Boca de Aroa** were affected by liquefaction. The houses only settled or tilted rather than completely collapsing shows that the structures maintained their overall integrity, preventing further economic and human losses.

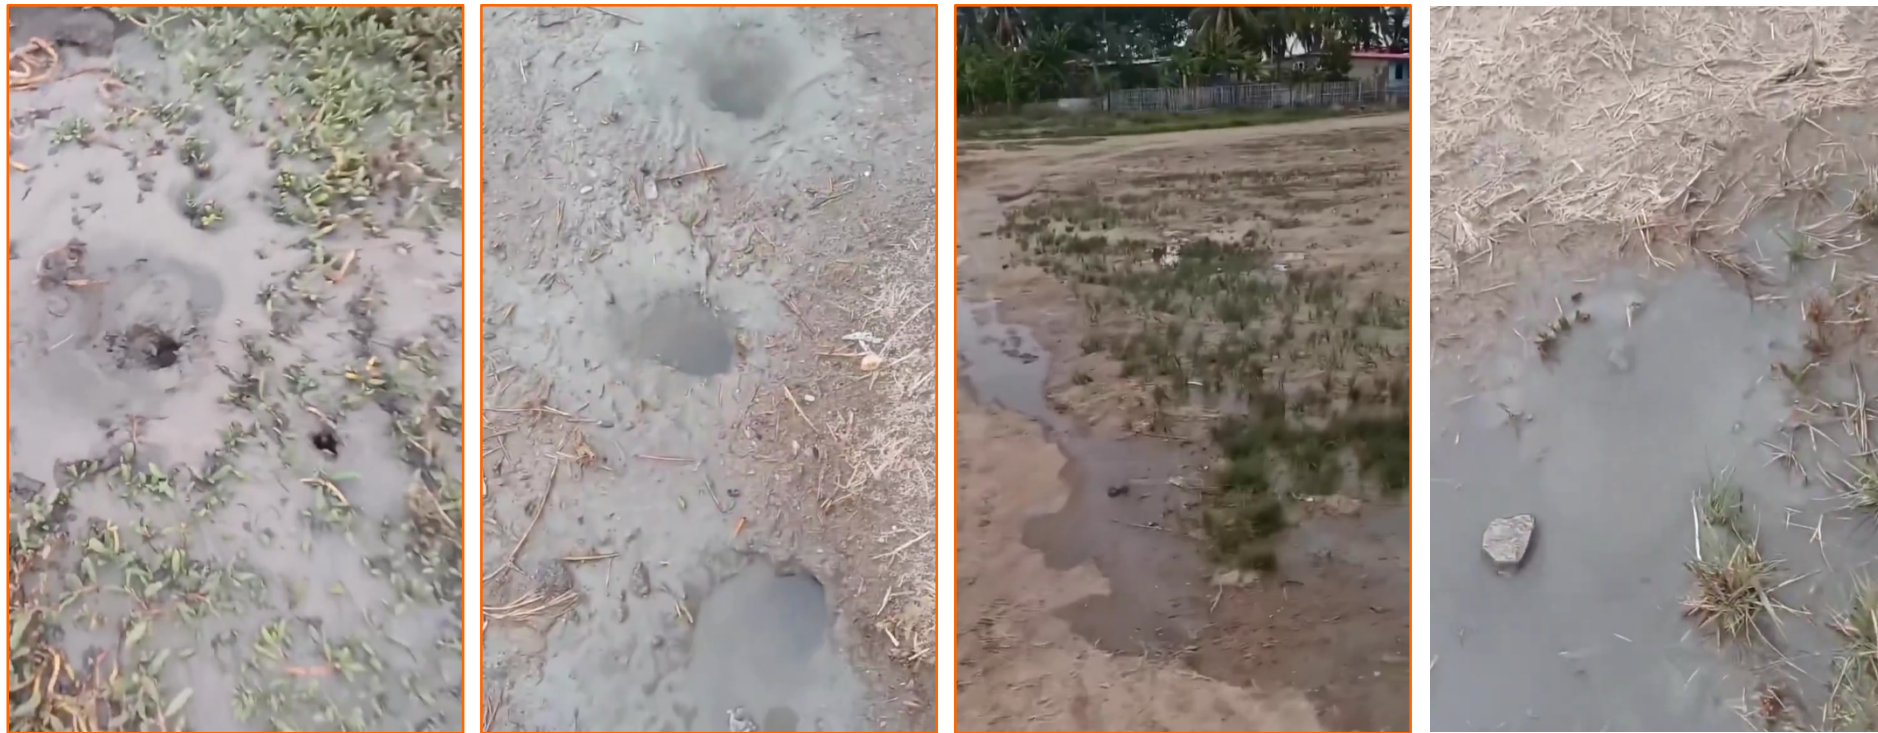
Liquefaction phenomena in the sandy soil of **Chuao area** of Aragua State, triggered by the 24 June 2026 major earthquakes in the northern part of Venezuela.

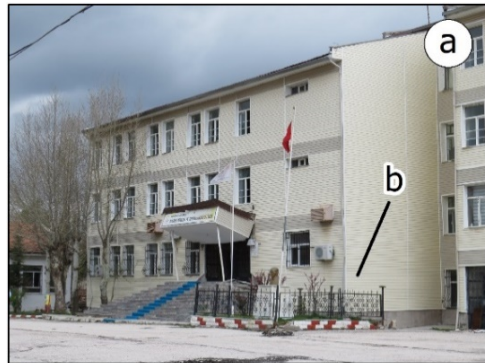
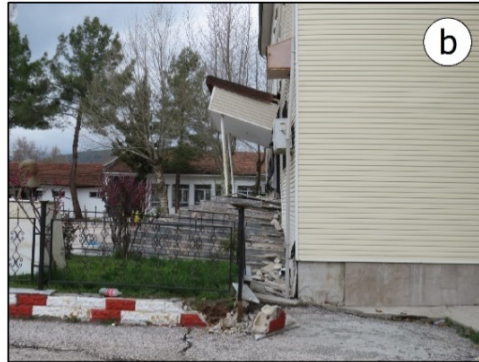
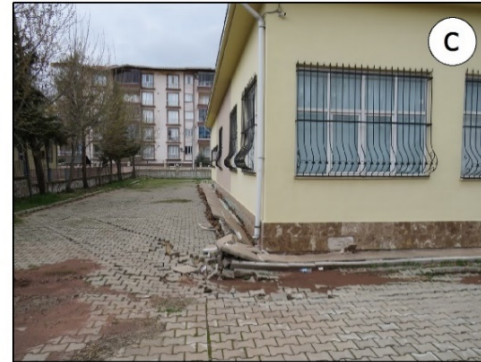
(a-d) sinking

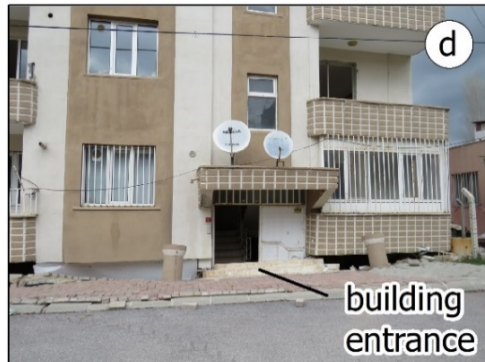
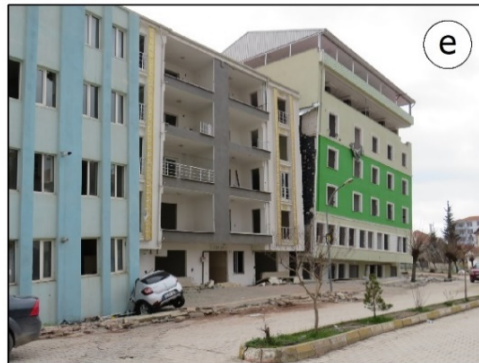
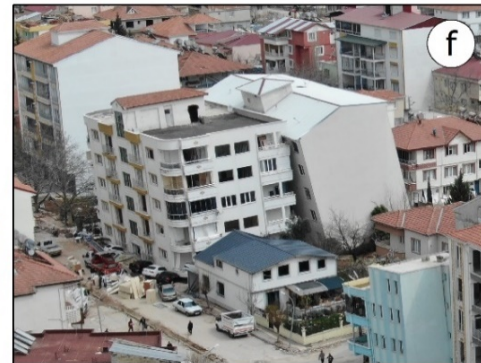
(e-g) tilting

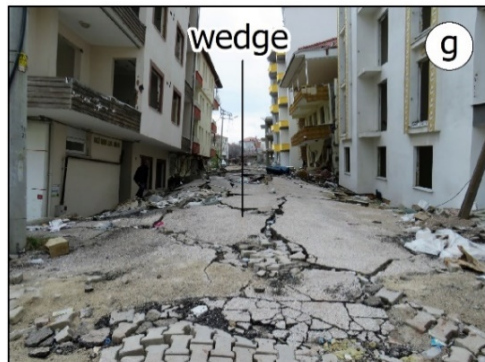
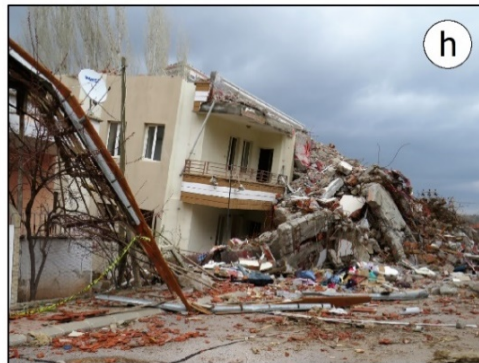
(h-i) collapse

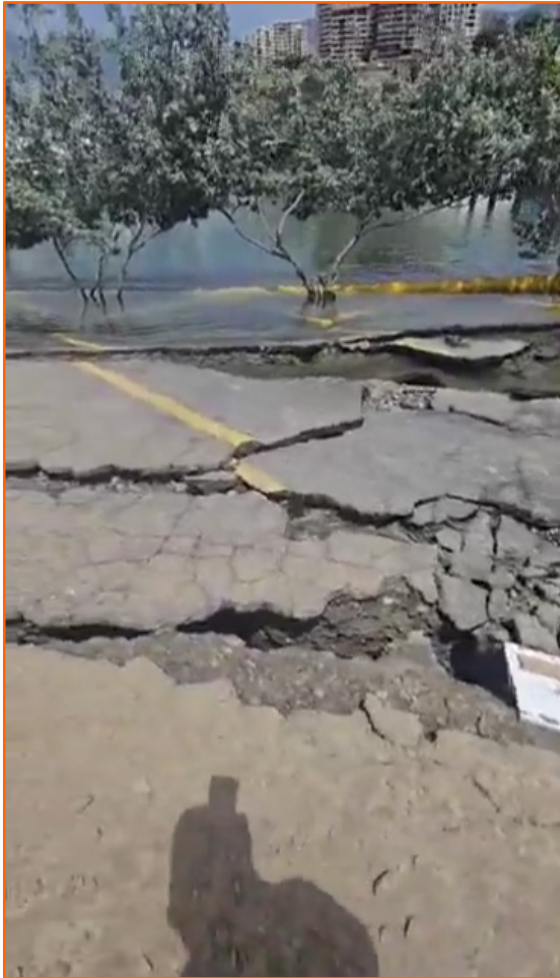
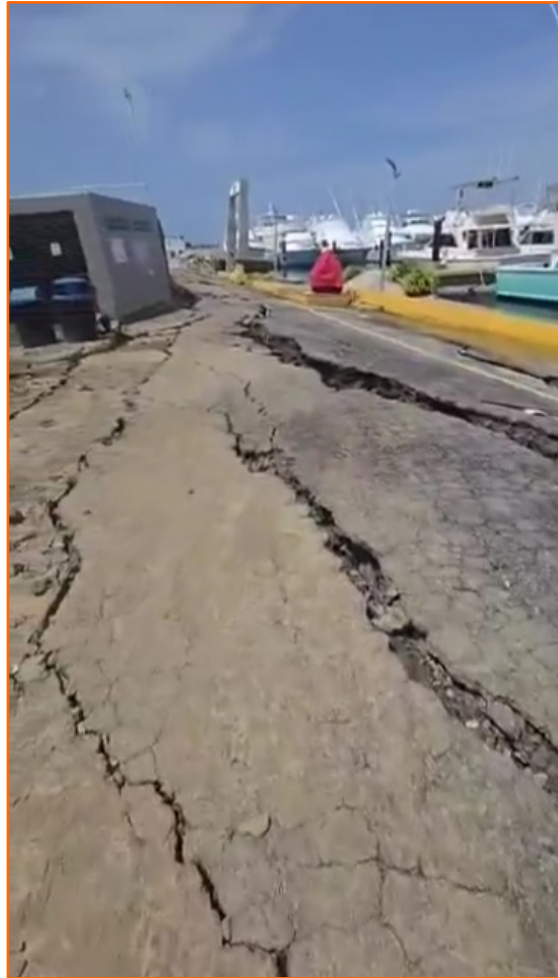
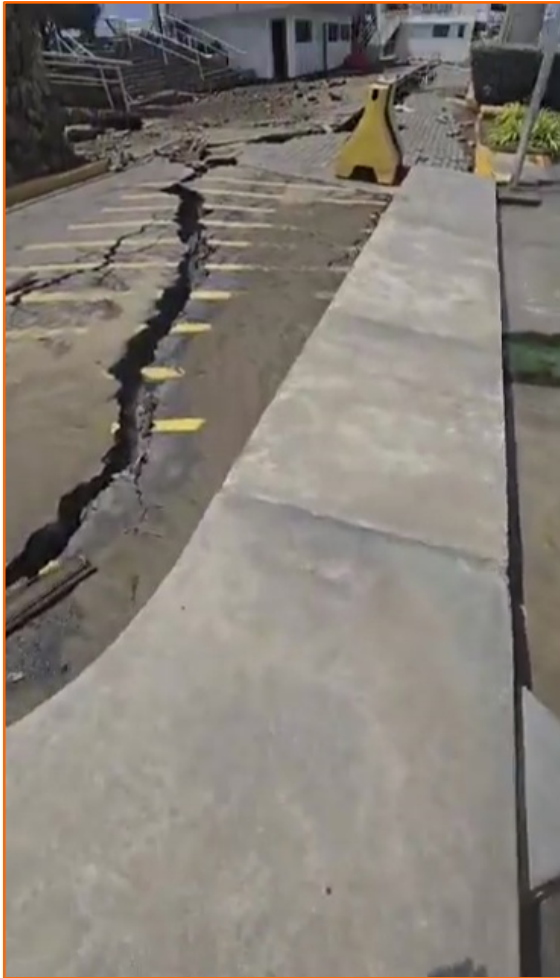
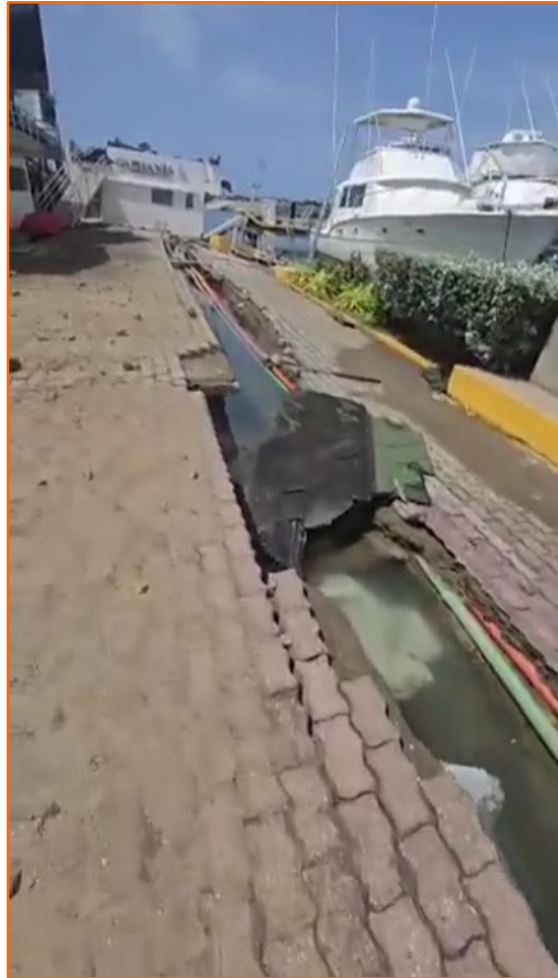
Snapshots from a video presenting liquefaction in **Marina of La Guaira** uploaded by Alerta Mundial [ @TuiteroSismico ]. Available online at: <https://x.com/TuiteroSismico/status/2070589357870772558>

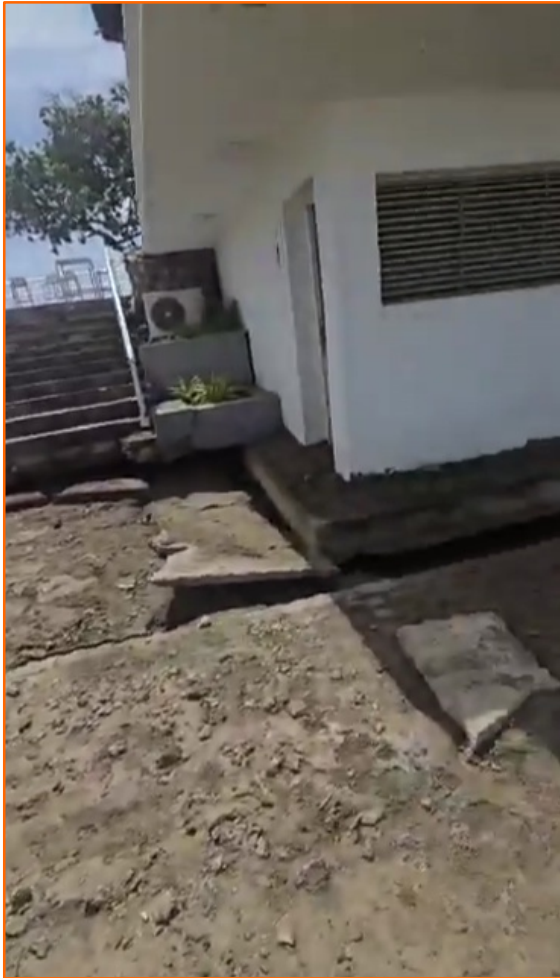
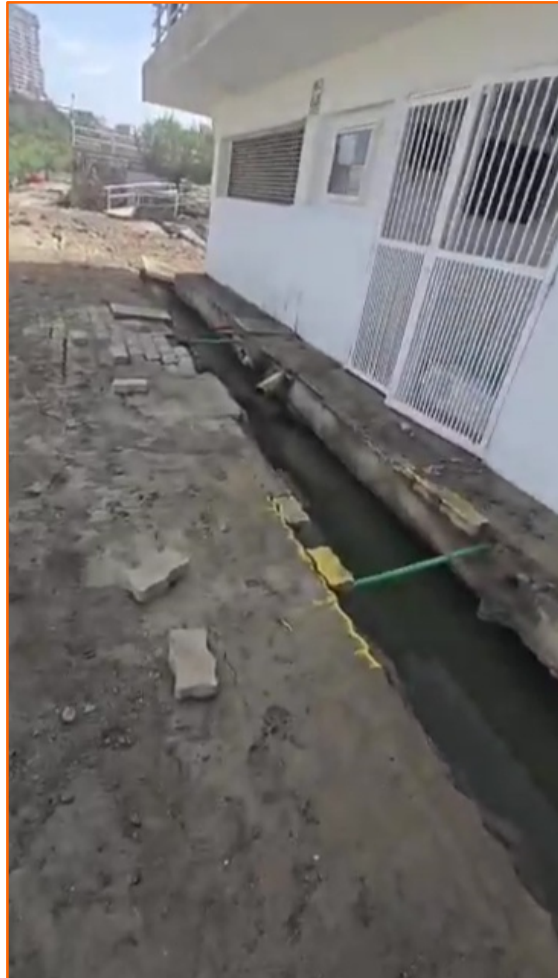
Snapshots from a video presenting liquefaction in **Marina of La Guaira** uploaded by Alerta Mundial [ @TuiteroSismico ]. Available online at: <https://x.com/TuiteroSismico/status/2070589357870772558>

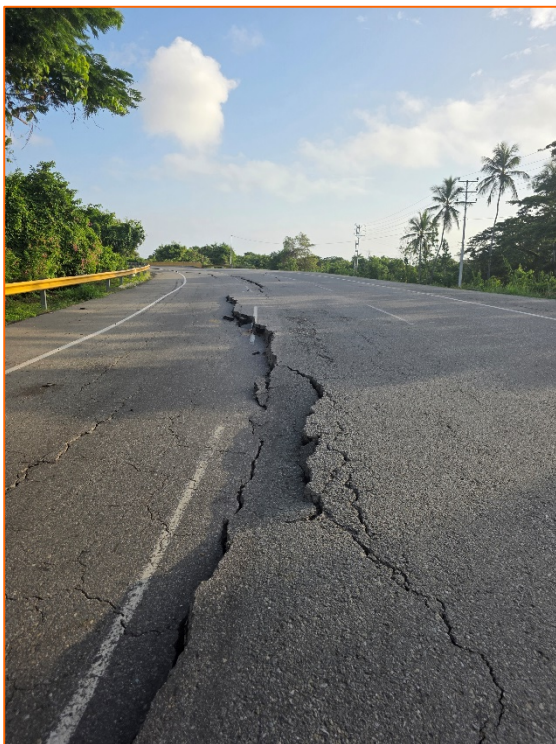
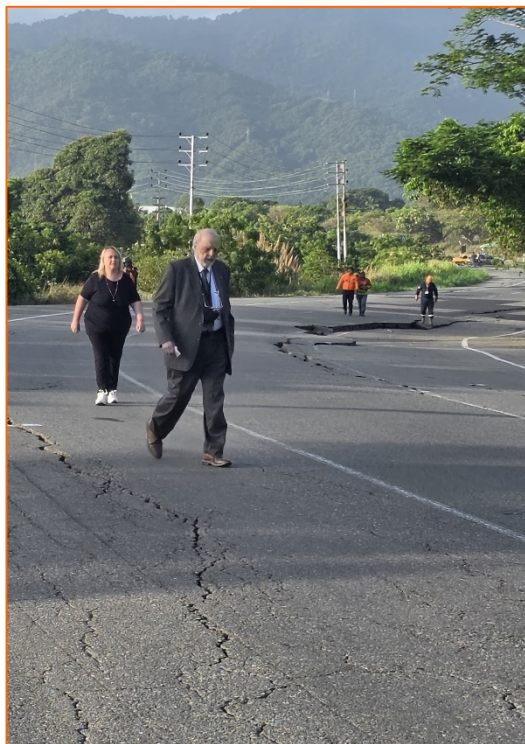
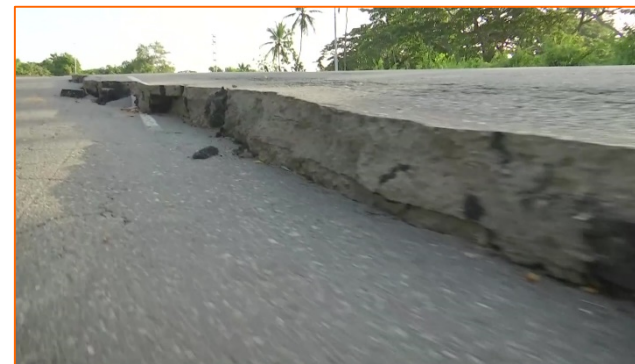
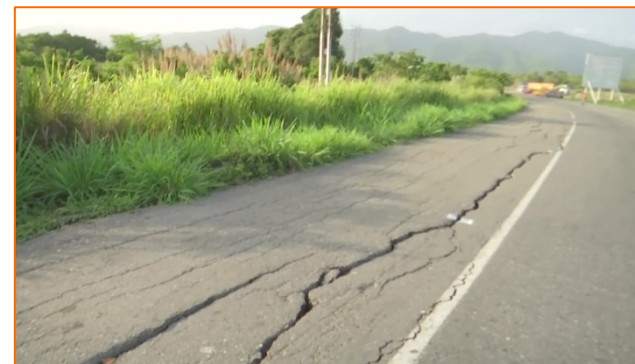
Ground cracks in a highway in Morón area located close to the epicenters of the 24 June 2026 earthquakes.

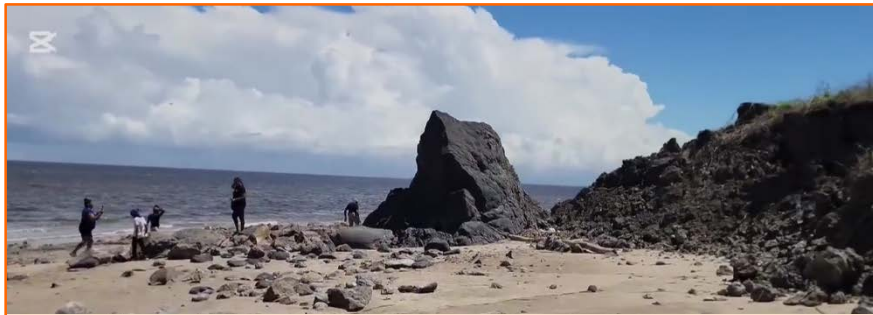
▲ ► Pre-seismic condition of Galfa Beach, showing geomorphic and structural features associated with mud volcano activity in the area.

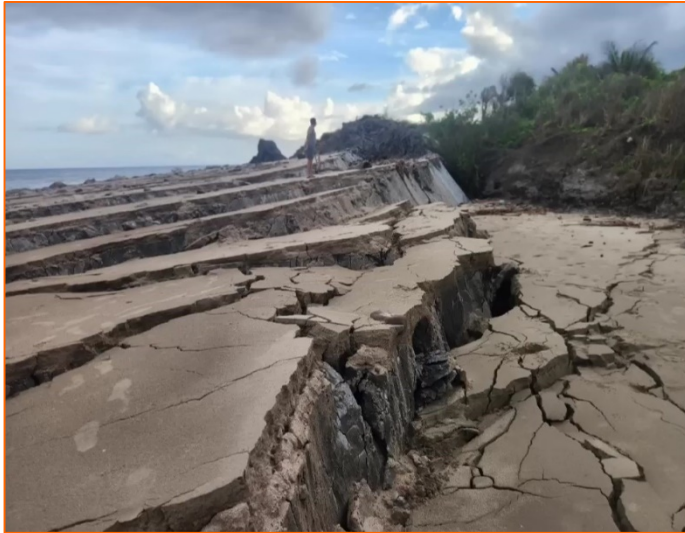
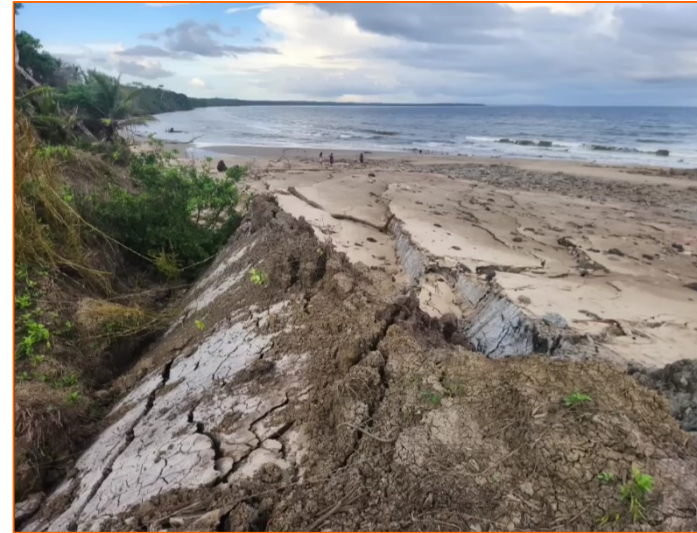
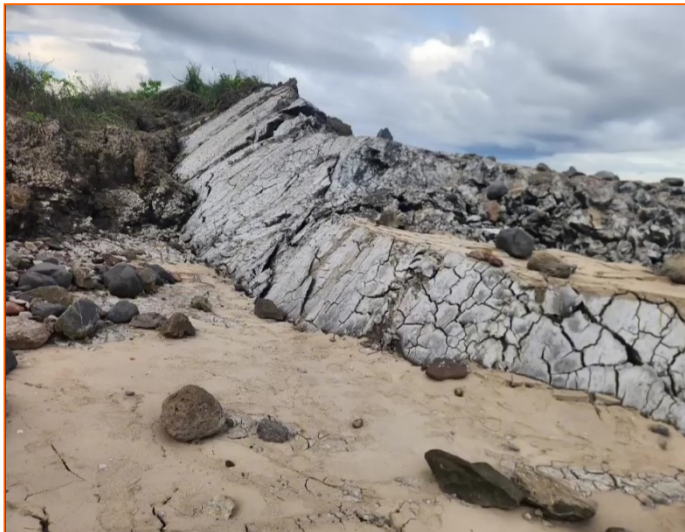
Typical views of the Galfa beach located at the southwestern part of Trinidad. The snapshots presented herein originate from the YouTube channel “South West Adventures” and specifically from the respective videos uploaded to the channel on 29 June 2026.

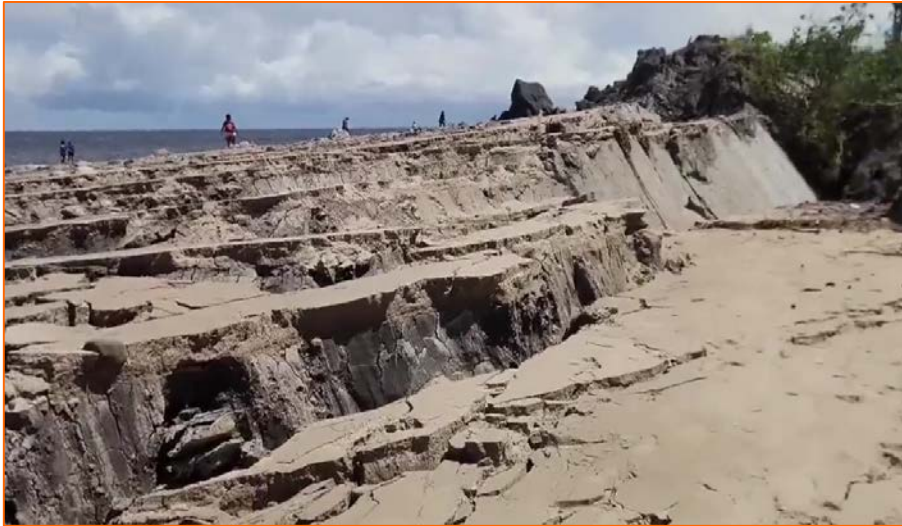
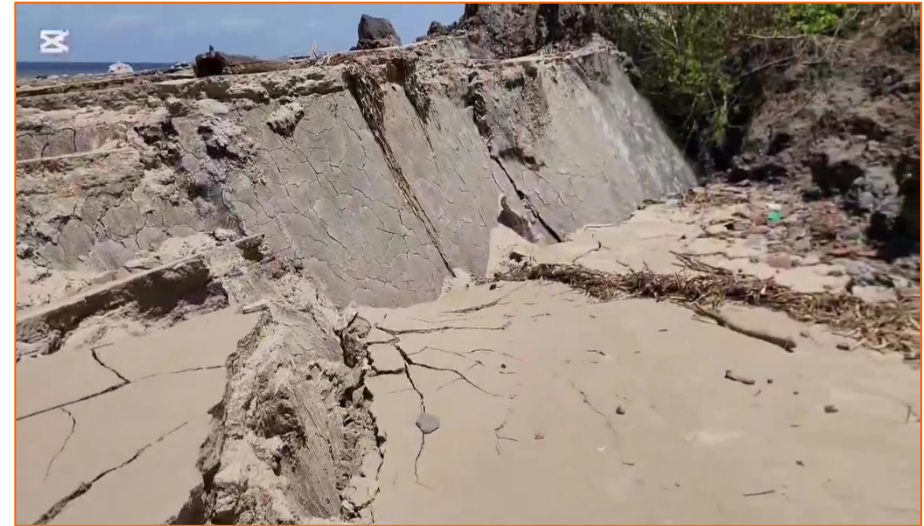
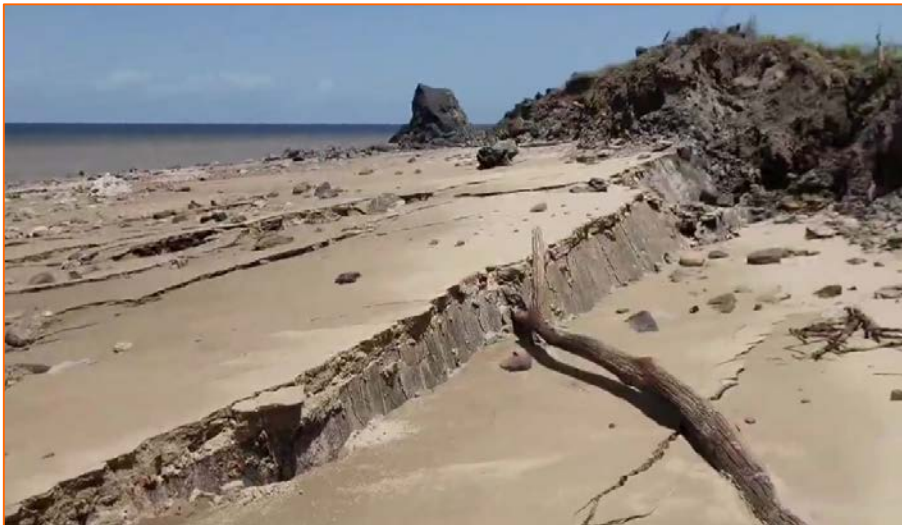
Typical views of the Galfa beach located at the southwestern part of Trinidad. The snapshots presented herein originate from the YouTube channel “South West Adventures” and specifically from the respective videos uploaded to the channel on 29 June 2026.

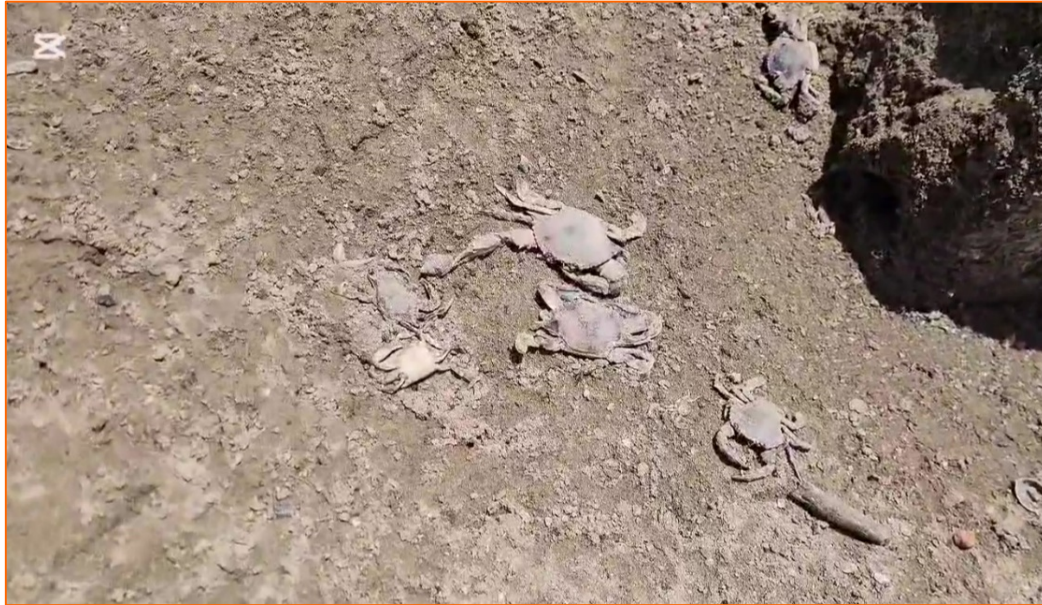
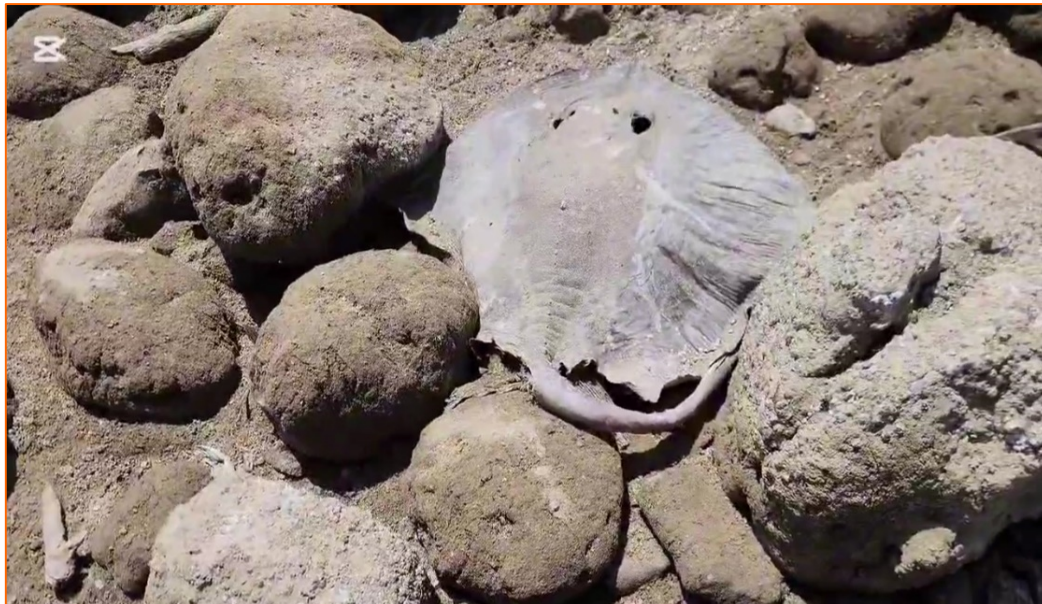
The coastal area experienced rapid uplift, resulting in the immediate retreat of seawater and the exposure of the seabed. Consequently, the marine organisms inhabiting the affected area were exposed to the air and perished due to the sudden change in their environment.

This uplift led to the exposure of a large portion of the seafloor and the consequent destruction of benthic and other marine organisms inhabiting the area, including fish, brachyuran crabs, bivalve mollusks (clams), and stingrays.

On the newly exposed seabed, small pools of trapped seawater formed. Within these pools, gas bubbling and the extrusion of sandy material to the surface were observed.

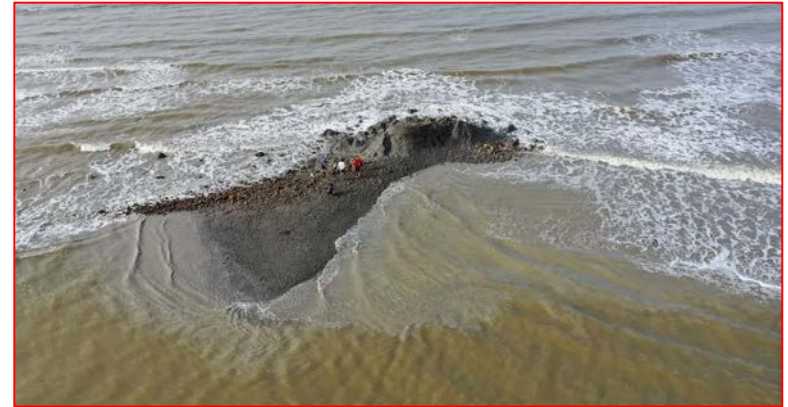
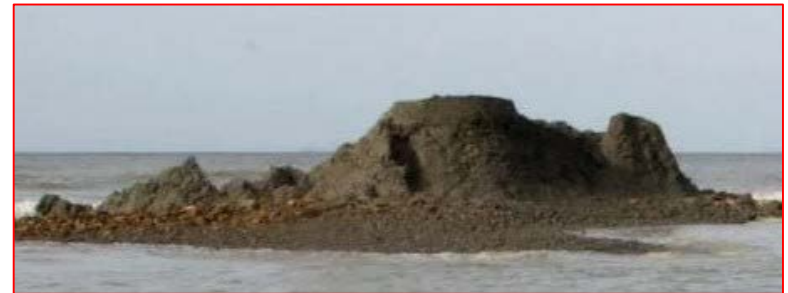
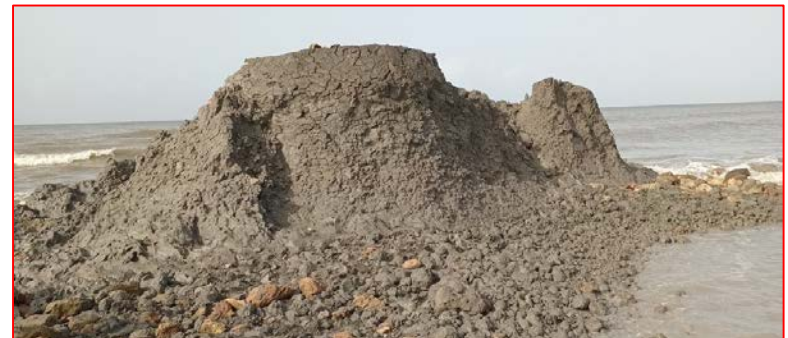
► Views of the newly formed mud feature in Palo Seco Bay (Trinidad and Tobago). Source: Reuters.

The emergence of this feature at Palo Seco Bay adds to a growing list of recent geological changes observed along Trinidad's south-western coastline. Scientists and local authorities are expected to monitor the site closely to assess its development, stability, and any potential implications for nearby communities and coastal ecosystems.
